# Investigation Report

Type of Occurrence:	Accident
Date:	28 December 2010
Location:	Near Jena-Isserstedt
Aircraft:	Helicopter
Manufacturer / Model:	MD Helicopters Inc. / MD 600N
Injuries to Persons:	Two persons severely injured, one person with minor injuries
Damage:	Aircraft destroyed
Other Damage:	None
Information Source:	Investigation by BFU
State File Number:	BFU 3X154-10

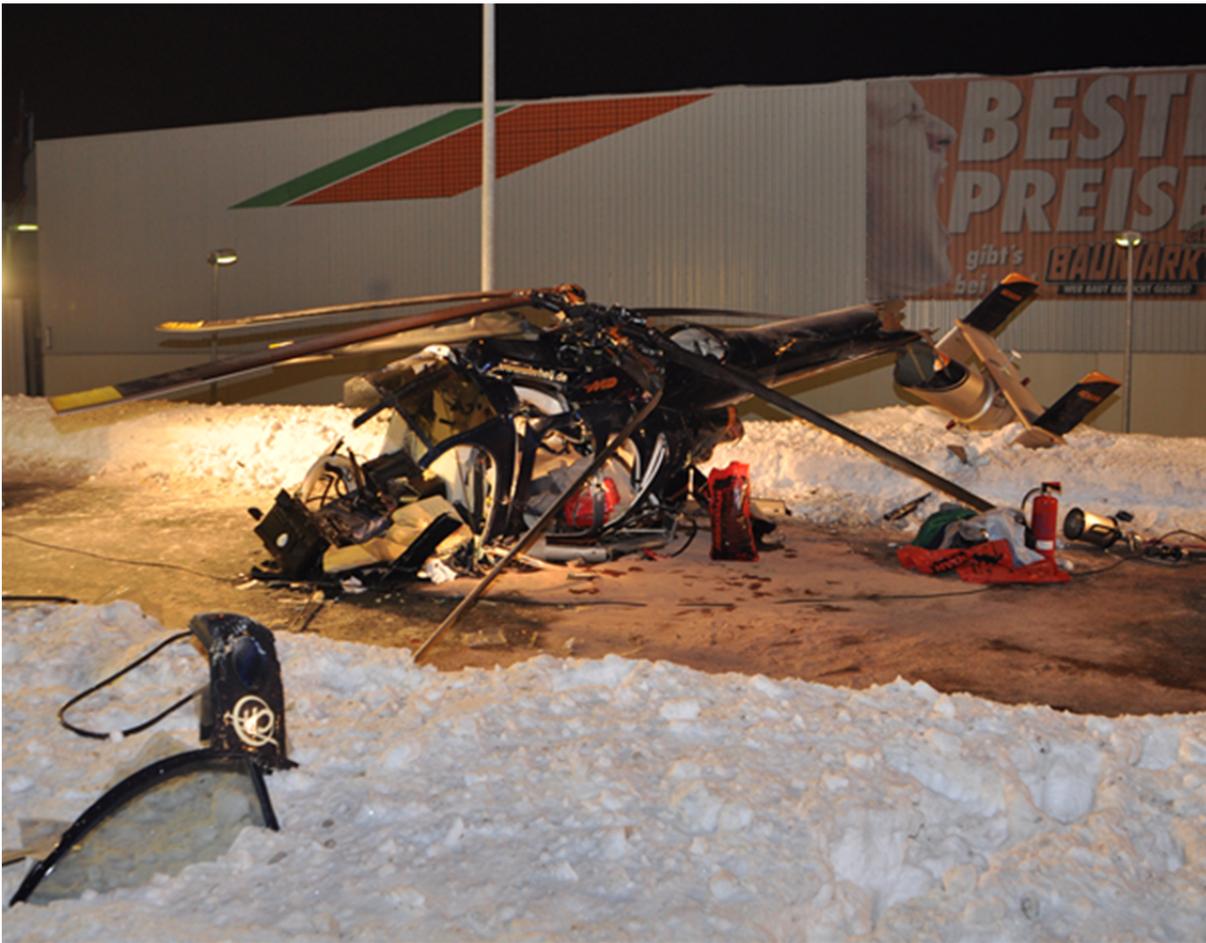
Accident site and helicopter wreckage

The helicopter lay on its fuselage; the left skid was severed and the right was bent outward from the fuselage structure. In the cockpit area the windscreen was destroyed and the instrument panel lay in front of the cockpit. The tail boom had become severed about 1 m from the tail section and was still attached to the fuselage via the push-pull-cable linkage of the NOTAR. All six main rotor blades were damaged; some of them were bent forward and down (direction of impact). The main gear box was pushed into the fuselage structure.

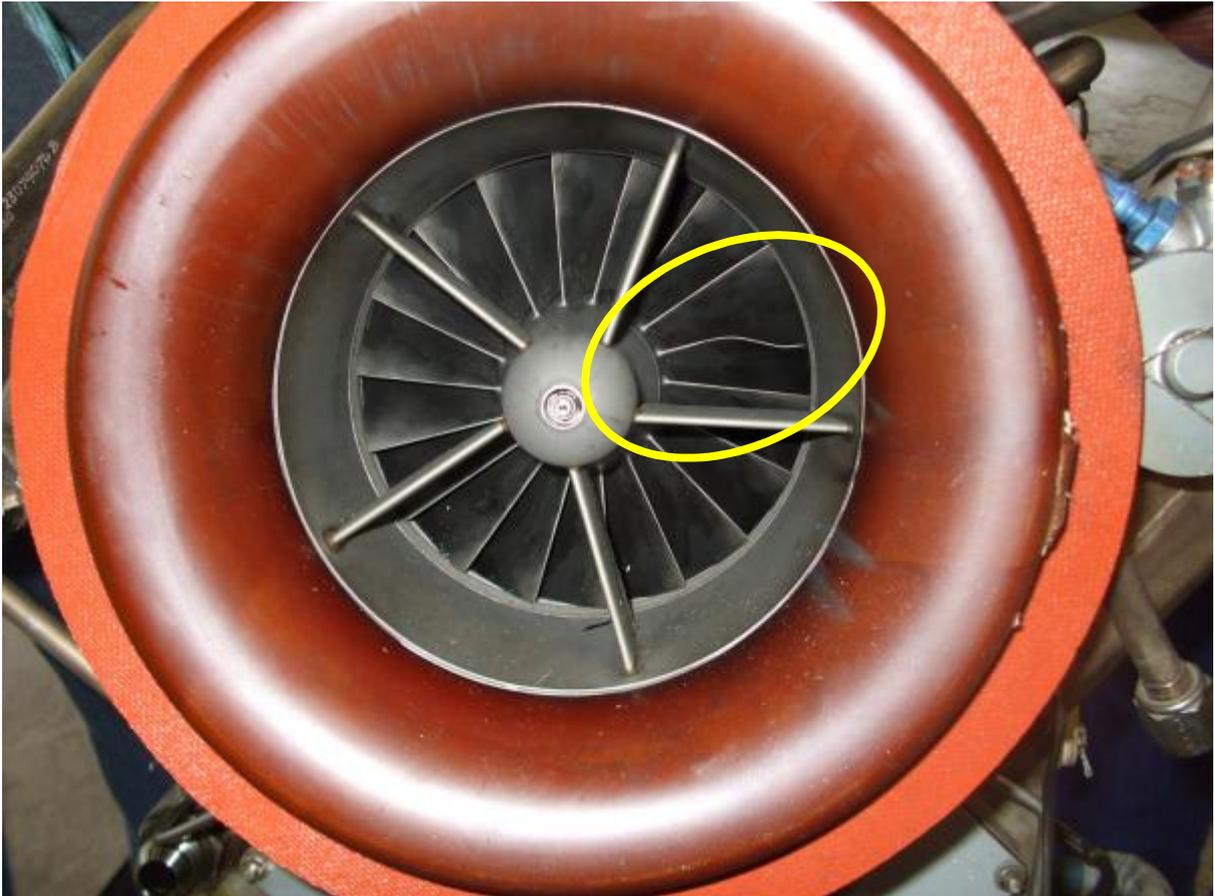
push-pull cable between the operating lever and the Bypass flap was connected; it was not possible to actuate the operating lever. The engine main drive shaft and the drive shaft of the NOTAR-Fan were severed in the area of the clutch on this side of the main gear box. The engine and the NOTAR-Fan could be moved manually without sound. The free-wheeling unit opened and locked as designed. Except for a bent compressor blade the engine showed no irregularities.

Damage on the engine compressor

The US American engine manufacturer examined the engine and the electronic control unit (ECU) in the presence of the National Transportation Safety Board (NTSB). No further damage besides the bent compressor blade was determined. Afterwards the engine was subjected to a test run in accordance with Rolls-Royce PTS 899 requirements (run as received). It was determined that engine start-up was normal and the engine accelerated to Ground Idle (N1: 31,212 rpm). Only an abnormal high pitched sound could be heard during acceleration. At 37,664 rpm acceleration was stopped due to vibrations.- Afterwards the engine was shut down normally. In summary, it was determined that the engine showed normal behaviour during start-up, acceleration up to 37,664 rpm and shut-down. The recognised abnormal high pitched sound and the vibrations during the testing were due to the bent impeller blade and the disruption of airflow through the engine.

The examination of the engine did not reveal a technical cause for the sudden engine failure. The damage found on one of the compressor blades supports the assumption that the engine failure was due to a sudden ingestion of ice. Already in the past small amounts of sucked-up and clumped-together snow and ice caused engine failures.

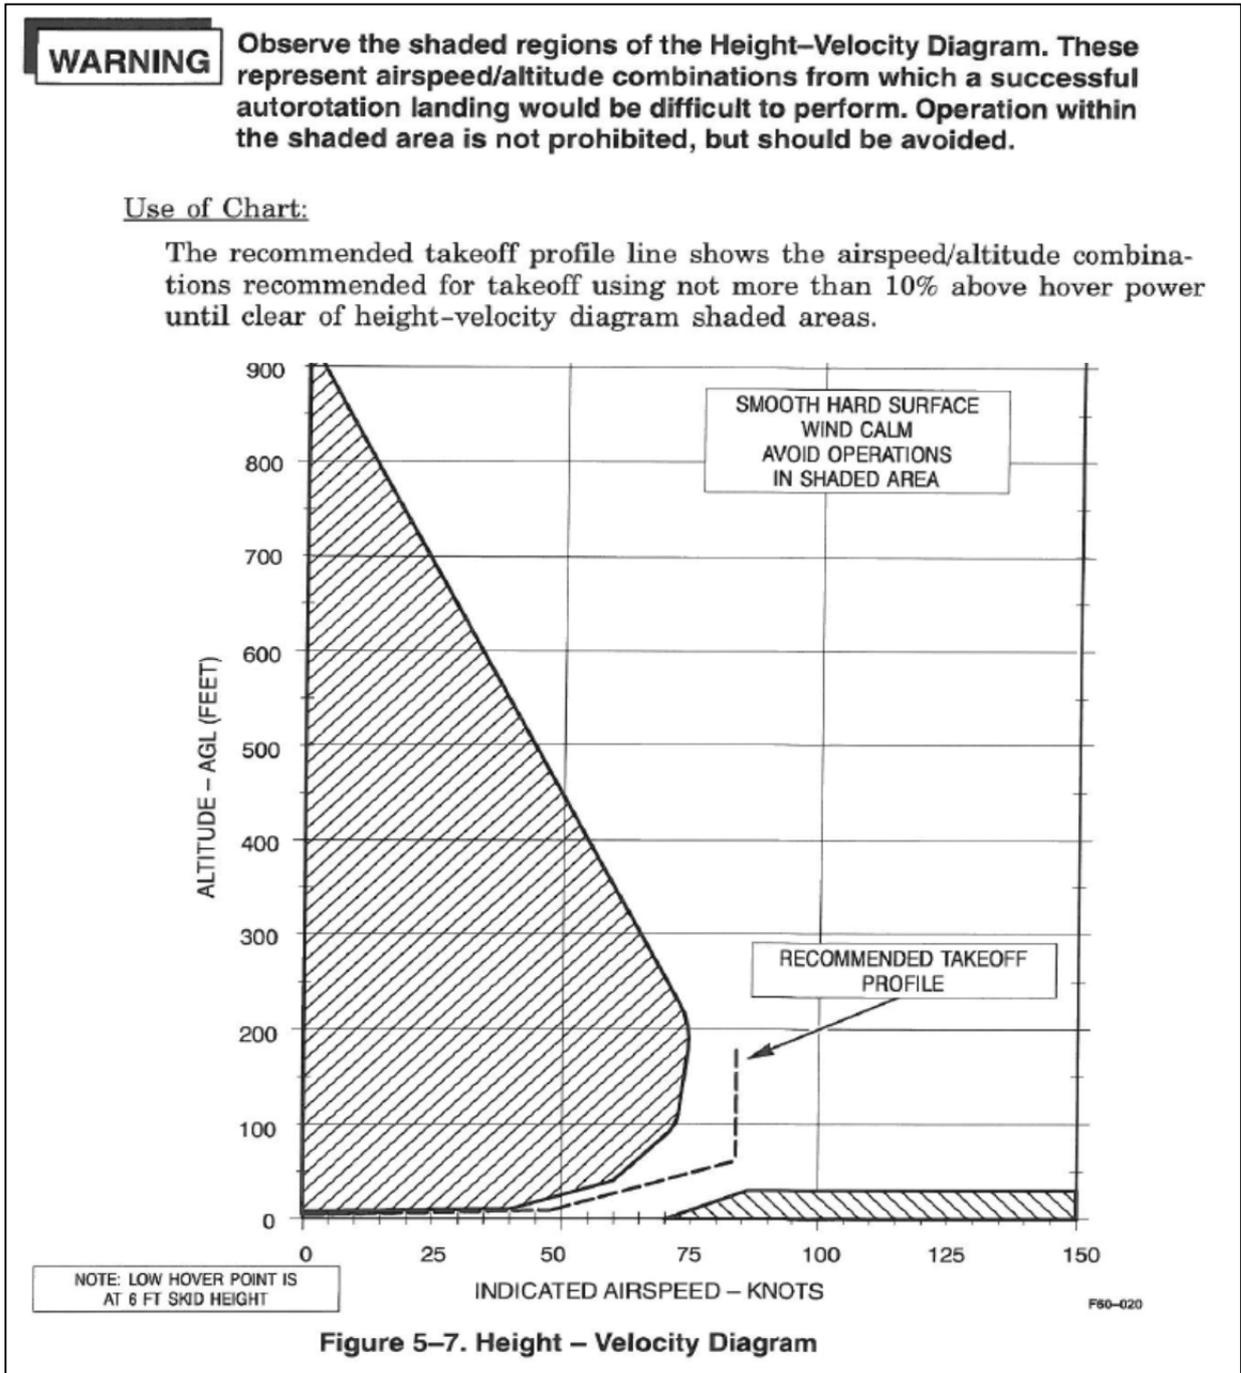
Single-engine helicopters can be autorotated to the ground in case of engine failure. In order for the autorotation to be successful the pilot's skills and a commensurate airspeed/altitude combination at the moment of the engine failure are critical. These

are described in the respective flight manual in the form of a Height-Velocity Diagram. Flight operations under observation of the Height-Velocity Diagram is strongly recommended (refer to the excerpt of the flight manual under Warning).

Height-Velocity Diagram for autorotations

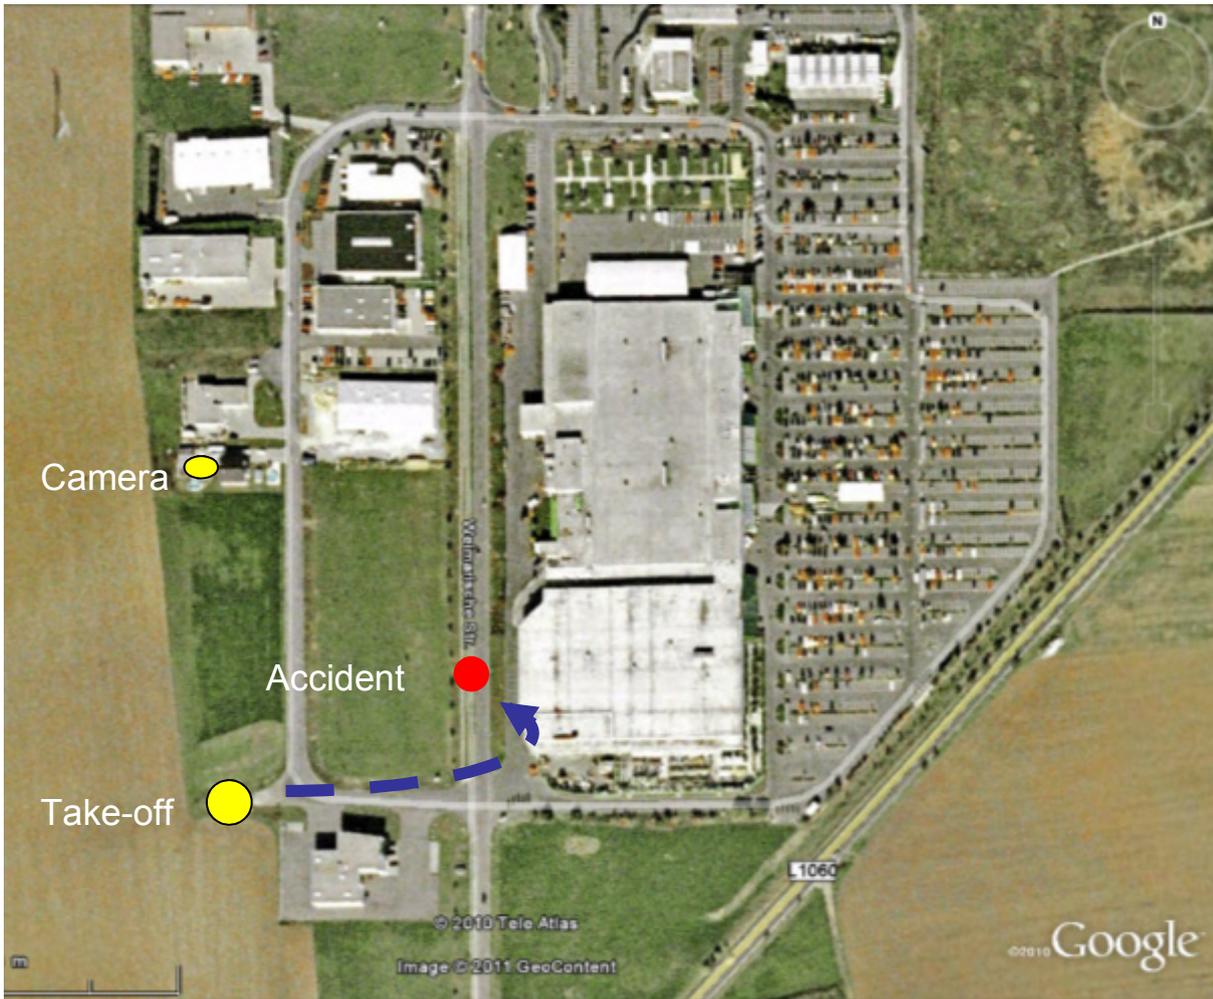
Appendix 1: Overview accident site

The crew stated that it was tried to execute an autorotation onto the street right in front of and perpendicular to the helicopter (Appendix 1).

The accident site was located about 800 m south-west of Jena-Isserstedt on a street west of the building supplies store running in North - South direction (see Appendix 1).

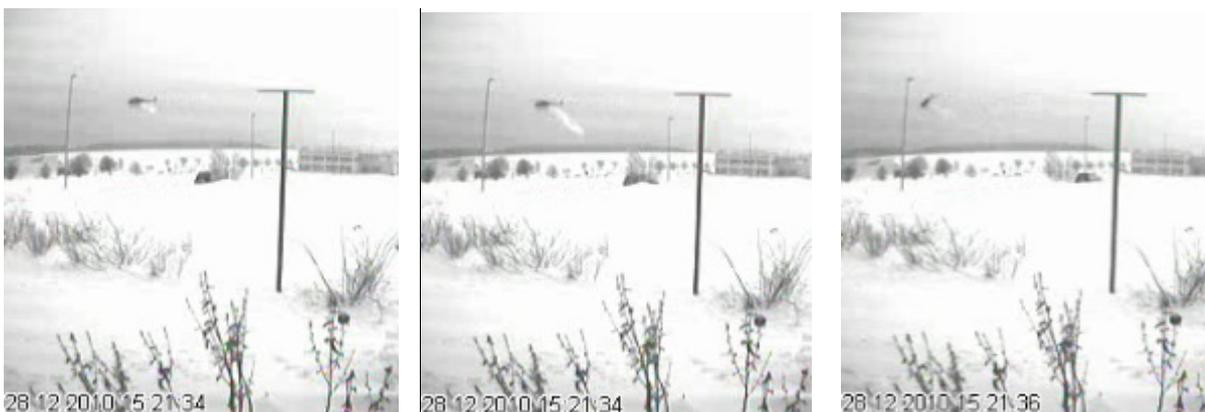
Appendix 2: Recording of the video surveillance

A video camera partly recorded the take-off of the helicopter. The recording allowed the drawing of conclusions concerning the course of events, the airspeed and height when the engine failure occurred (see Appendix 2).

The accident occurred shortly after take-off during the approach to a store after an off-field landing in a cleared street. The chosen landing area was not closed off and due to its small size and the high snow mounts and the closeness to a road not very suited. The downwash raised a snow cloud during landing and take-off due to the missing snow clearing. This caused the pilot to take-off vertically out of the snow cloud. In a flight phase with low forward speed the engine failed. A video recording showed that the engine failure and the helicopter's impact with the ground occurred within 4 seconds.

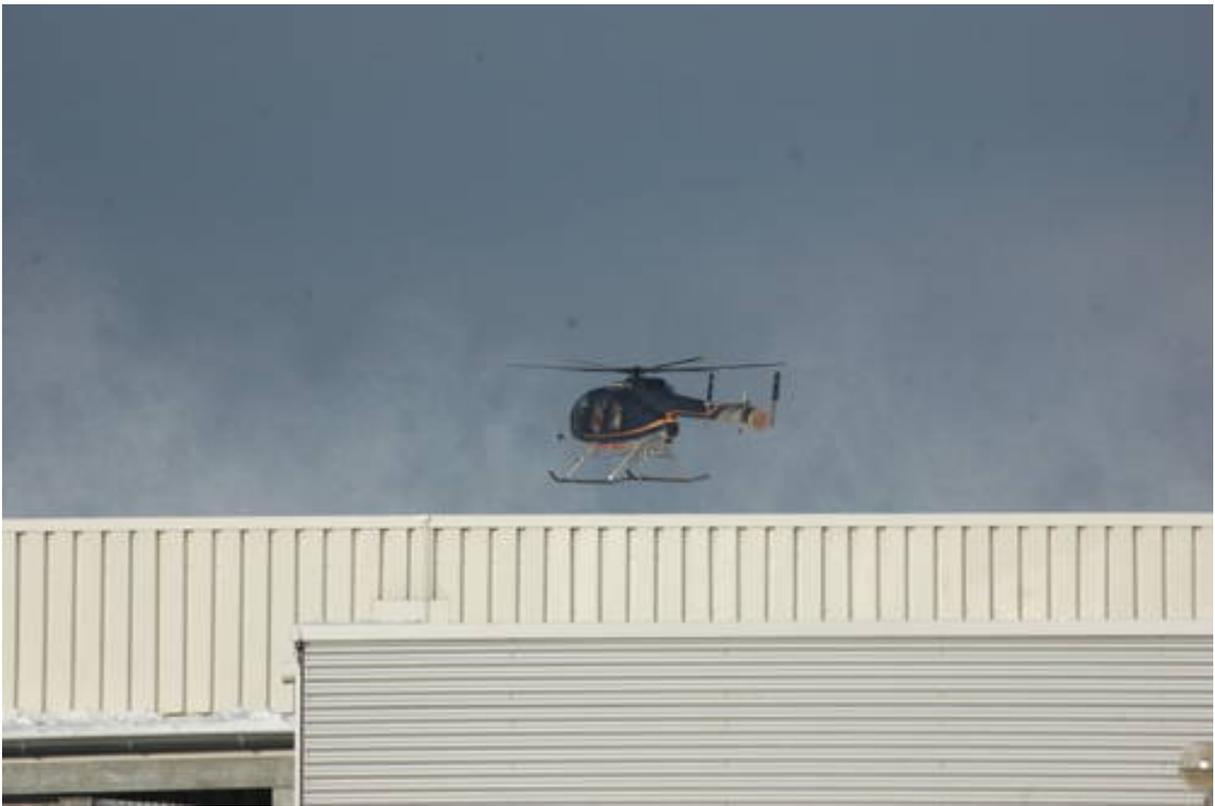
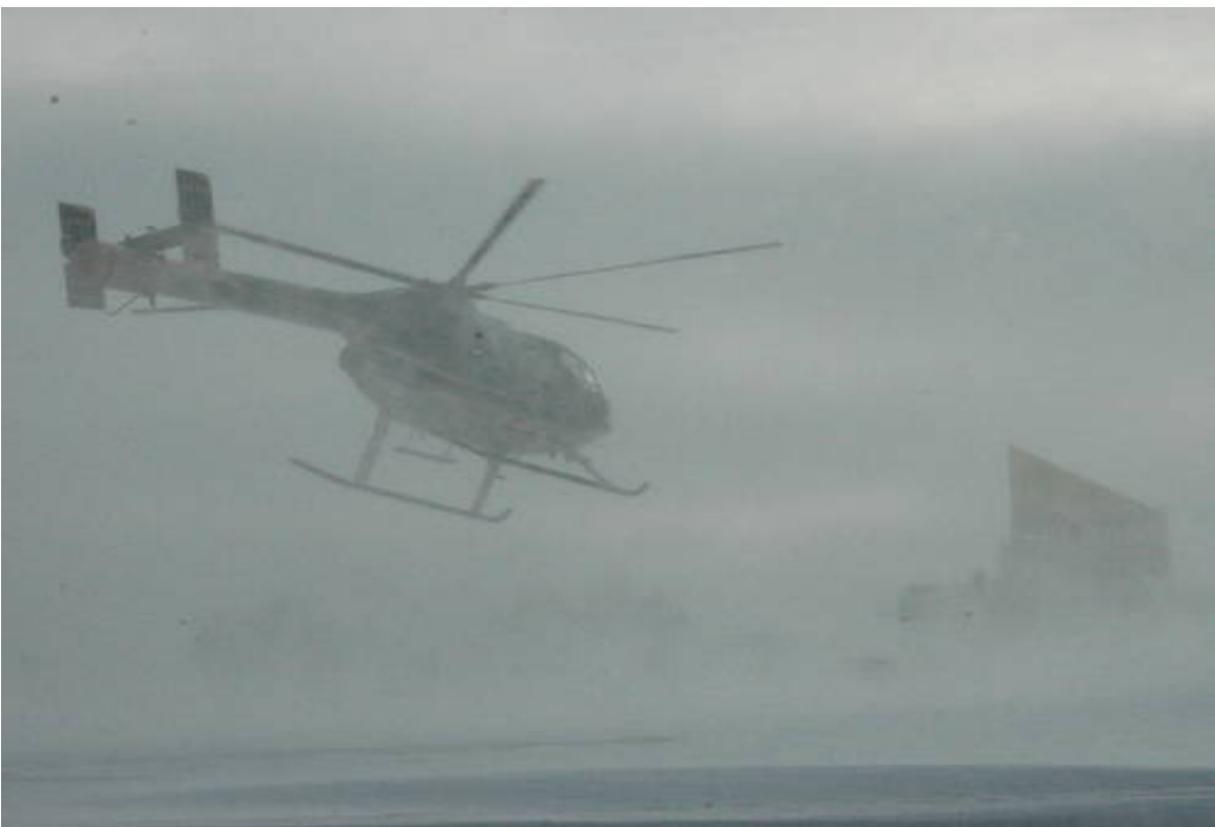
Appendix 3: Angled view of the helicopter from the ground during snow clearing      Photos (2): Press
