**AVIATION INVESTIGATION REPORT
A06W0041**

AIRFRAME FAILURE AND COLLISION WITH TERRAIN

**RUPERT'S LAND OPERATIONS INC.
McDONNELL DOUGLAS MD600N C-FTAZ
ZAMA LAKE, ALBERTA, 25 nm NW
21 MARCH 2006**

Report Number A06W0041

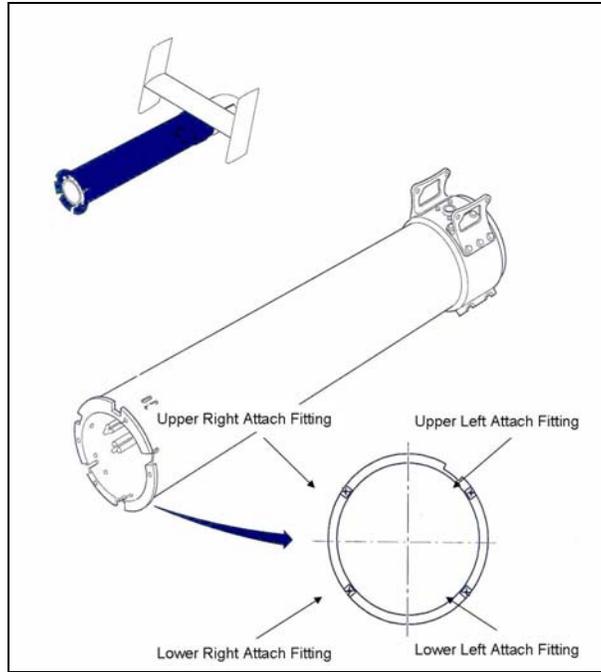
Figure 2. Tail boom assembly (copyright 1999-2006 by MD Helicopters Inc.)

The tail boom of the helicopter was attached to the fuselage at four locations by two, 5/16-inch-diameter bolts at the upper right and lower left positions and two, 3/8-inch-diameter bolts at the upper left and lower right positions (see Figure 2).

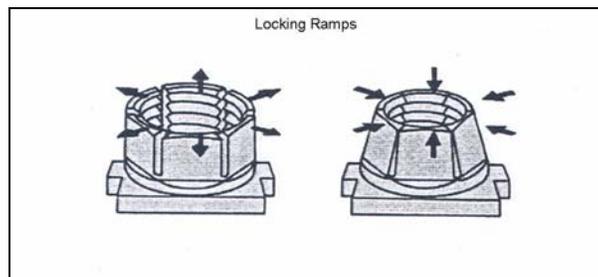
Figure 3. Tridair flatbeam locknut

The upper left attachment bolt had pulled through the locknut. The threads of both the bolt and the locknut show damage consistent with a shearing motion. The upper left attachment bolt was fully engaged and extended through the nut by three to four threads. The locknut has six flexible beams (Figure 3 locking ramps) that provide the locking function as the bolt is tightened. One of the six beams was broken off, and a second beam was cracked but still attached; it broke off when slight finger pressure was applied. A third beam had several small

cracks emanating from the inner surface. Cracking was evident in all three beams emanating from the roots of the internal threads, initiating and leading from the corners formed by the intersection of the threads with the vertical cut slots. The TSB Engineering Laboratory confirmed the cracking was due to fatigue. The exposed surfaces of the cracks had rub markings, which destroyed any fine detail of the nature of the fatigue.

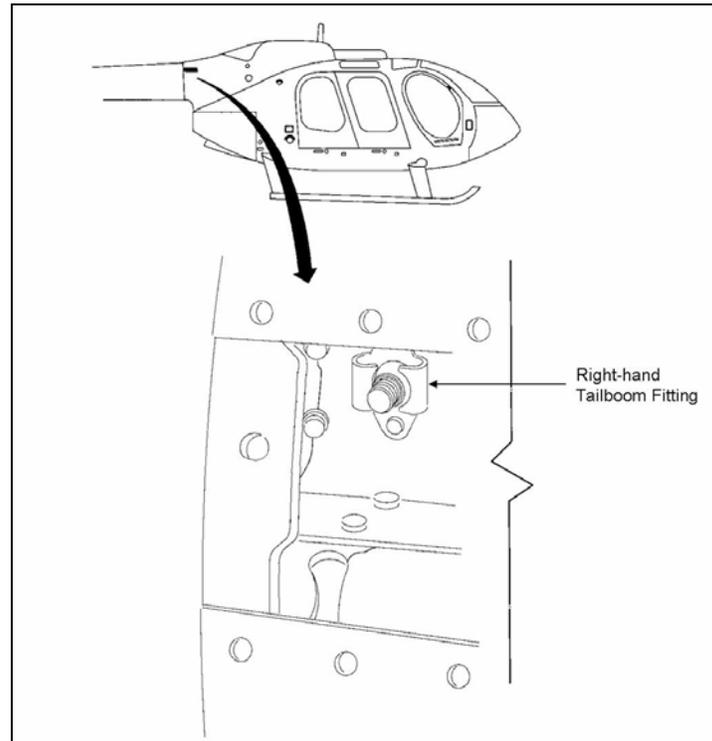
Figure 4. Tail boom attach fitting and angle (copyright 1999-2001 by MD Helicopters Inc.)

The upper right attach fitting (see Figure 4) had separated due to the failure of the fitting. This in turn caused the failure of the attaching section of the fuselage ring frame. Of the two brackets that attach the fitting to the frame, one was missing and the second had fractured through one of the attaching rivet holes.

The fracture surfaces of the fitting appeared fresh and had a bright, crystalline appearance, with the exception of the crack surfaces between the two inboard rivet holes, which were coated with a black deposit. The deposit was determined to be fretted material. The complete failure of the bathtub fitting was consistent with the fatigue cracking through more than 95 per cent of the cross section of the fitting. The failure of the fitting resulted in the transfer of load to the aft ring structure, causing a section of the ring structure to separate during the final failure sequence.

Fatigue cracking of the upper right attach fitting occurred, resulting in the transfer of loads to the aft ring structure and remaining three tail boom attach fittings. The resulting onset of fatigue in the locknut flexible beam elements of the upper left attach fitting, which compromised the strength of the fastener, allowed the upper left bolt to pull out of the locknut. Failure of the two upper attach fittings caused overload and separation of the lower two attach fittings. This resulted in the detachment of the tail boom and loss of aircraft control. Safe recovery following this type of structural failure would be unlikely.

1. The attach fitting at the upper right attachment point of the tail boom failed in fatigue. The transfer of loads to the adjacent aft ring structure resulted in the cascading failure of the remaining three tail boom attach fittings and separation of the tail boom from the fuselage.
2. Aircraft control was lost following separation of the tail boom. Safe recovery following this type of structural failure was unlikely.

On 13 April 2006, McDonnell Douglas Helicopters Inc. (MDHI) issued SB600N-043 requiring a borescope inspection of all four attach fittings. Within 25 hours of receipt of the bulletin, the attach fittings are to be replaced. On 13 April 2006, MDHI issued Technical Bulletin TB600N-007R1 regarding modification of the fuselage aft section and tail boom to strengthen the tail boom attach fittings and upper longerons.

On 27 April 2006, the Federal Aviation Administration (FAA) issued Airworthiness Directive (AD) AD2006-08-12. This AD requires that additional inspection holes be created in the aft fuselage skin panels, and that inspection of the upper and lower tail boom attach fittings, the upper longerons, and angle and nut plates for cracks be accomplished. It also requires, within a specified time, replacing the aluminum upper right tail boom attach fitting with steel fittings, painting the inspection area, and replacing existing nut plates.
