AIRCRAFT ACCIDENT REPORT

BH/2013/02/27/F

**Report on the Serious Incident involving
Bristow Helicopters Ltd
Sikorsky S-92 with Registration
5N-BOA at MMA Lagos, Nigeria
On 27th February, 2013**

Aircraft Accident Report No: BH/2013/02/27/F

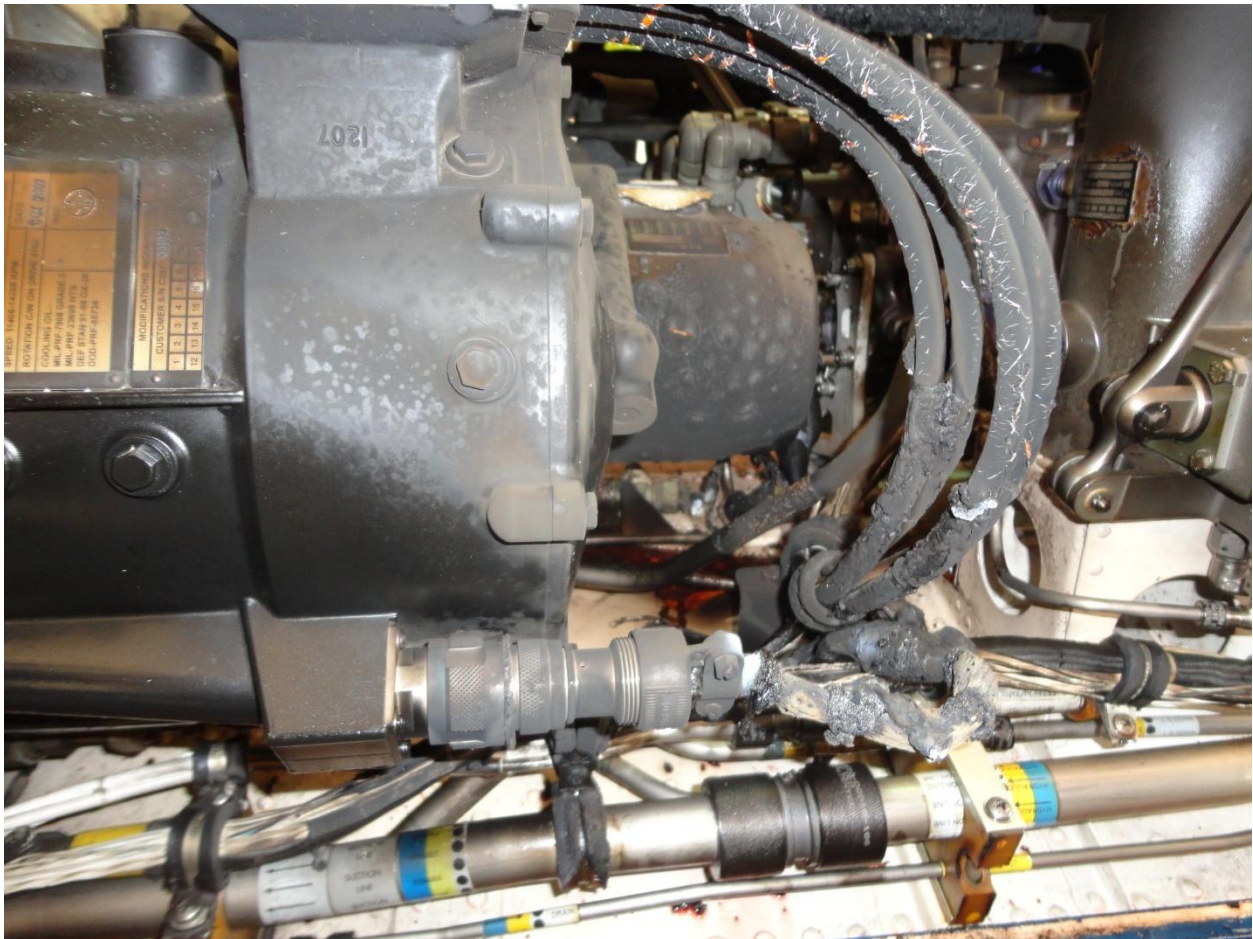
The damage was around the forward area of the rotor, the cowlings, the right heat exchanger and all the wiring in that area, hydraulic fluid lines and other pipelines were burnt. All the components located in the top cowling area forward of the main rotor gearbox were damaged by the fire. See Figures 1 and 2 below:

Figure 1: The burnt section of the upper deck

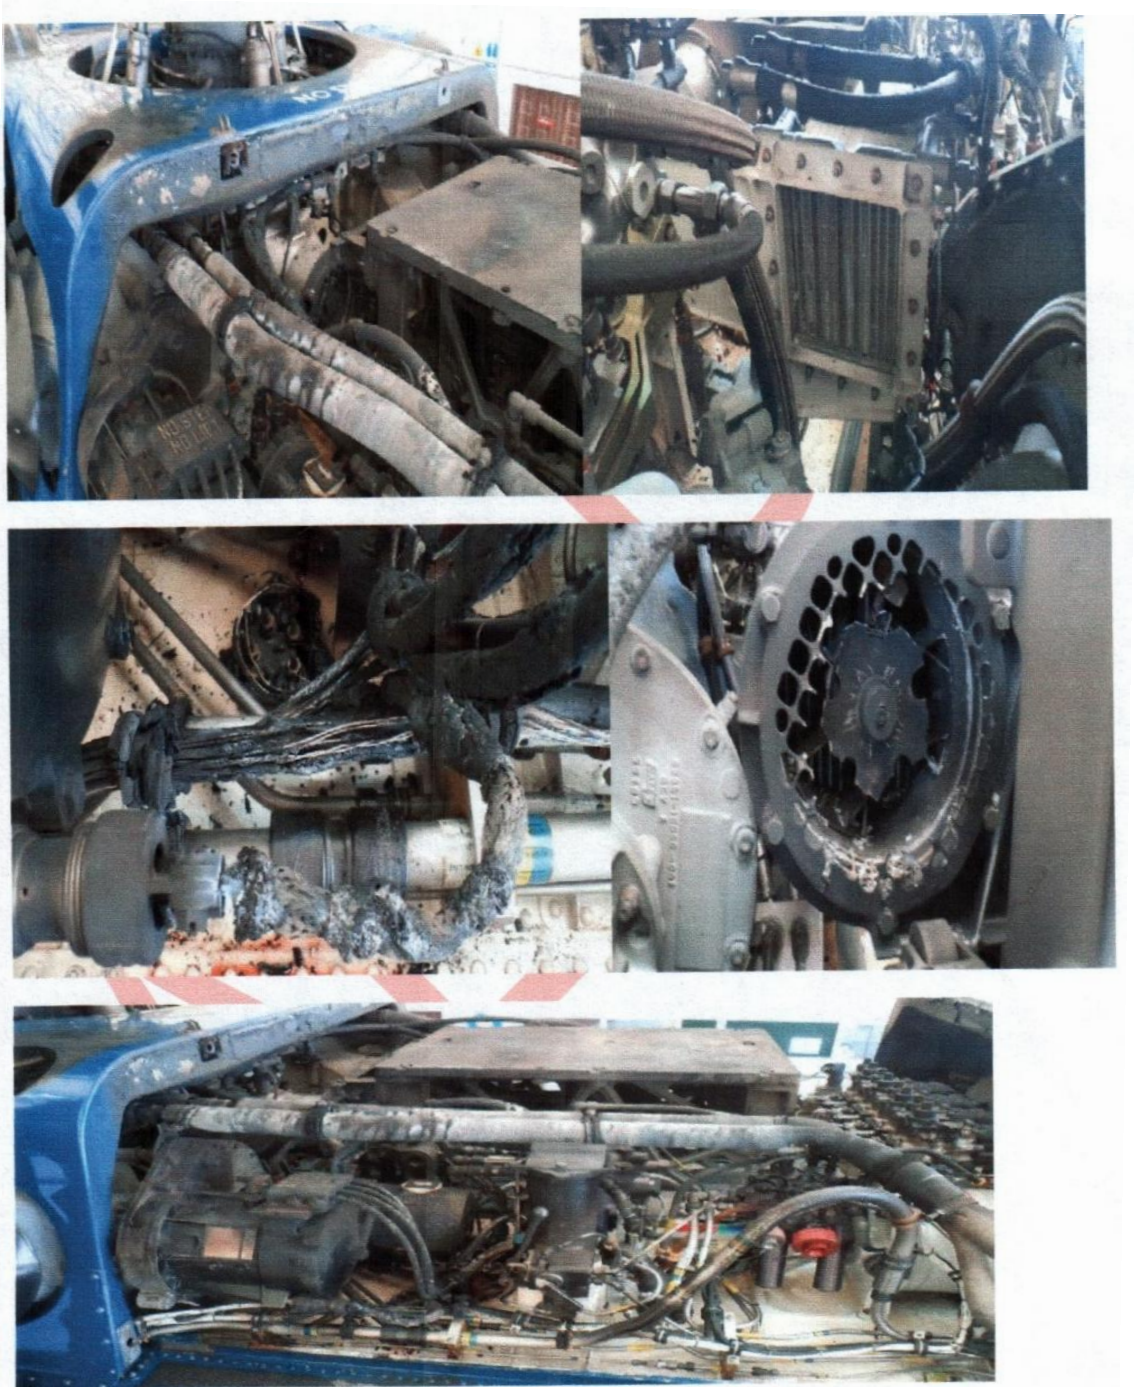
Figure 2: Different damaged areas of the upper deck caused by the fire outbreak

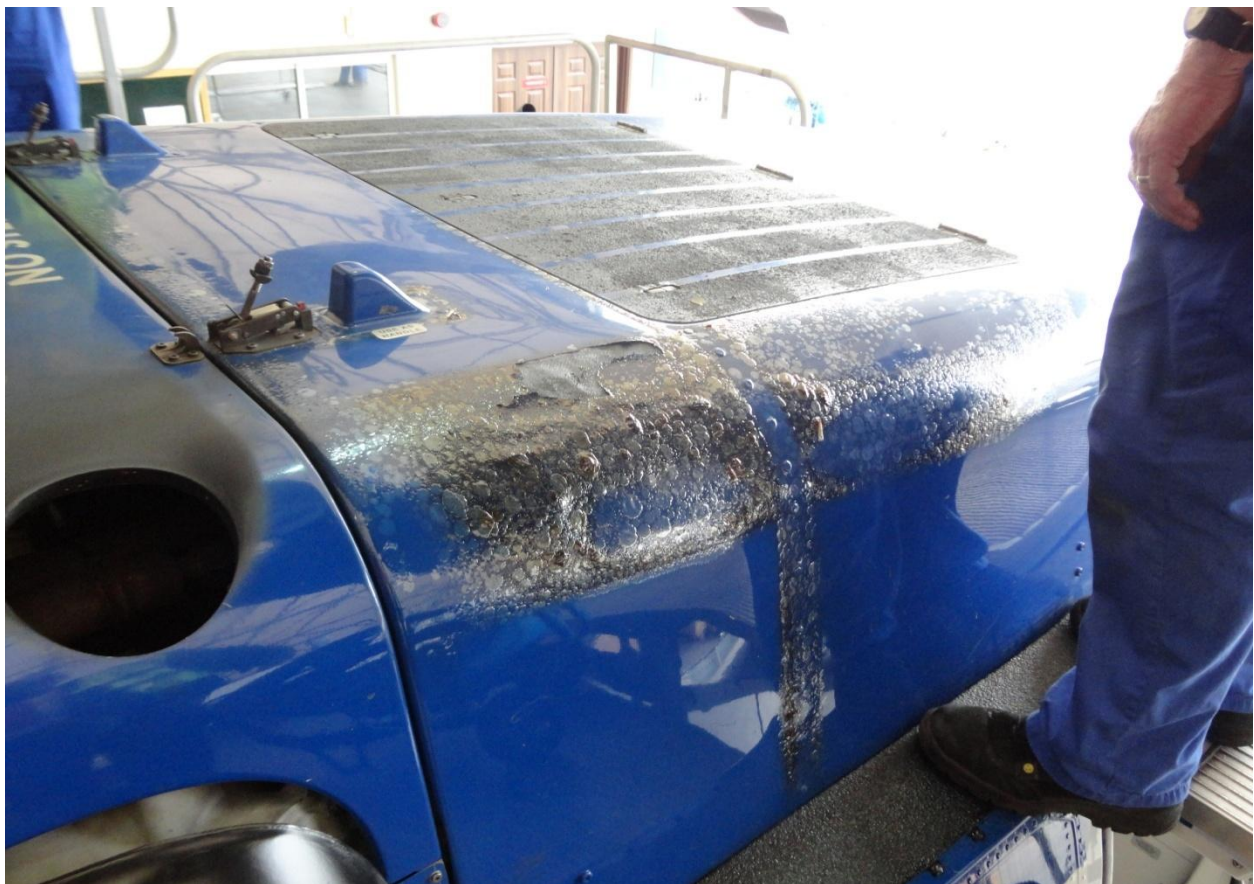
There was fire outbreak as a result of chafing of the electrical harness, arcing and hydraulic leakage which enhanced the fire around the Upper Deck Heat Exchanger Area.

Figure 5: Burnt Cowling

- 3.1.11 Emergency Engines Shutdown and Evacuation was initiated after the rotor stopped.
- 3.1.12 There was discoloration of the cowlings partly due to hydraulic leakage and fire.

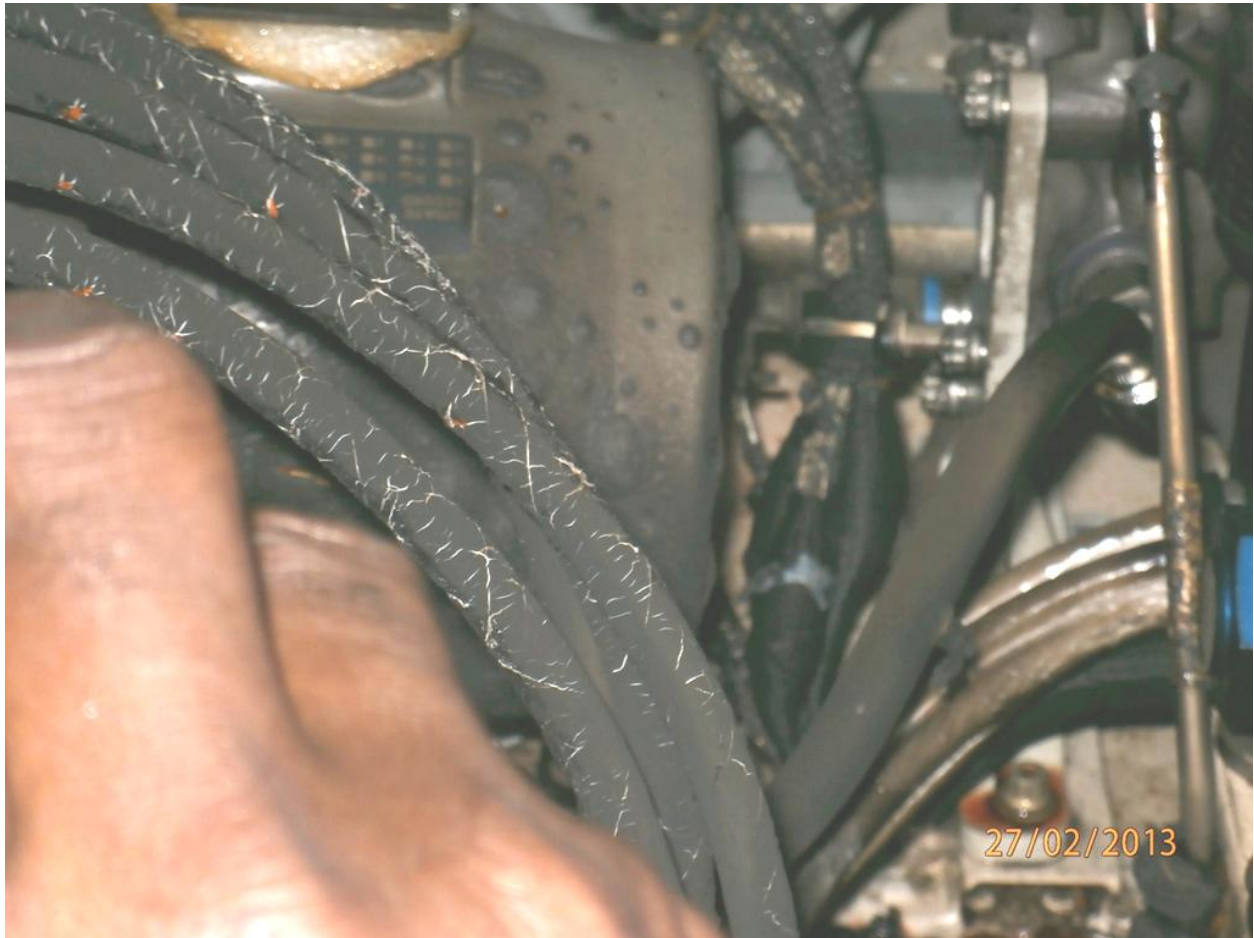
Figure 6: Burnt hoses

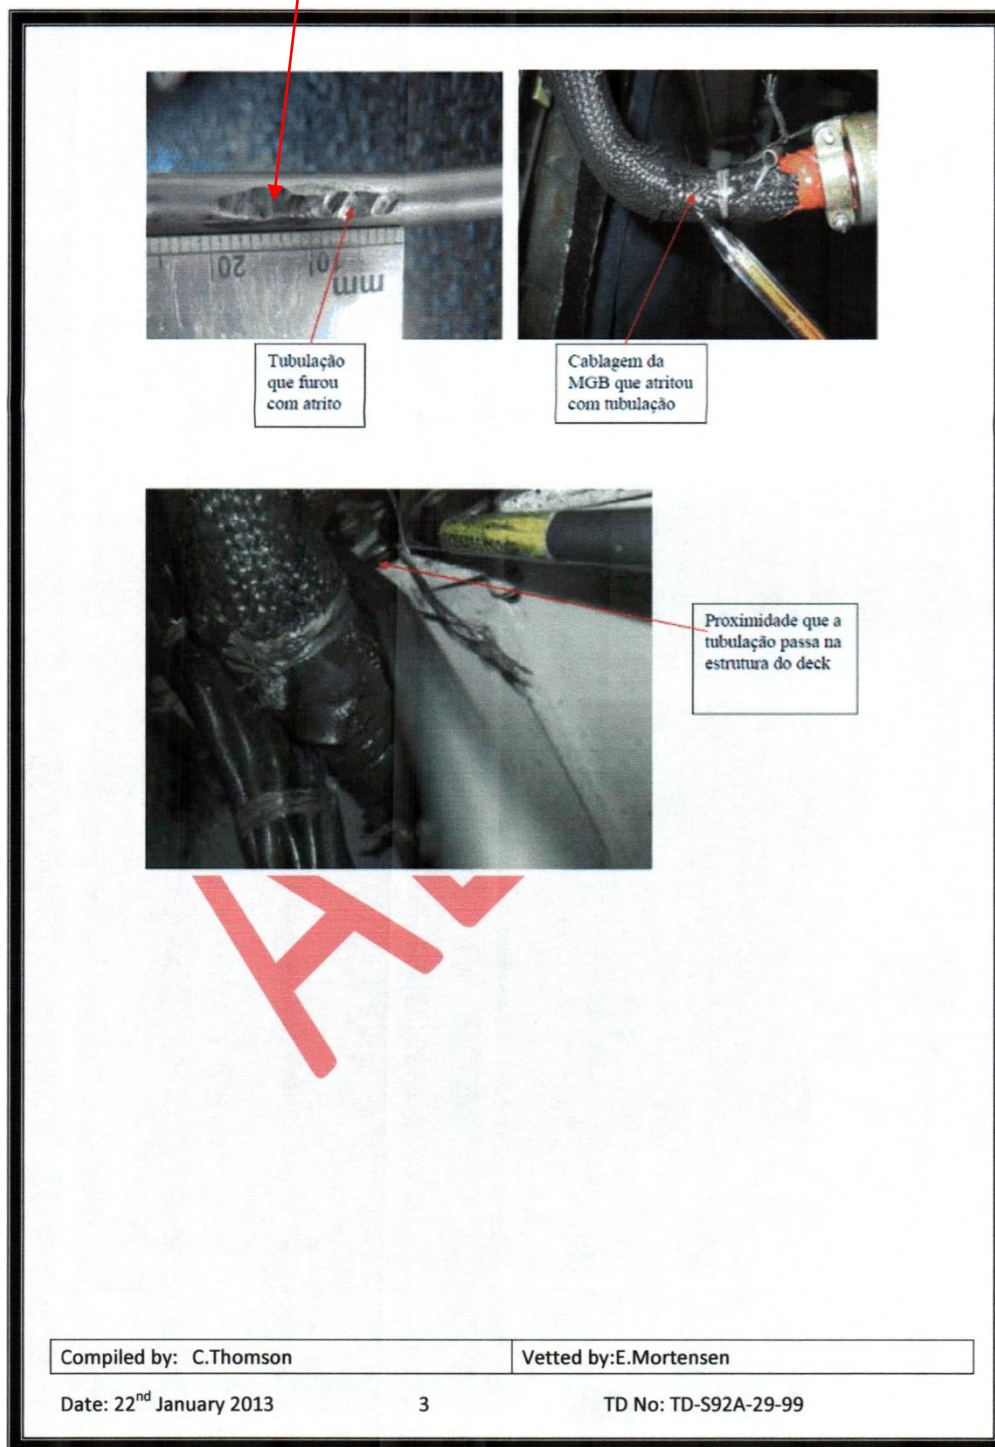
Page 3 of the TD showing hydraulic chafed line

Figure 13 Hydraulic Chafed Line

115v cable loom chafed and arced with hydraulic pipeline, puncturing it and causing high pressure leak which ignited on contact with hot surface of the Right Hand heat exchanger, resulting in fire on the Upper Deck.

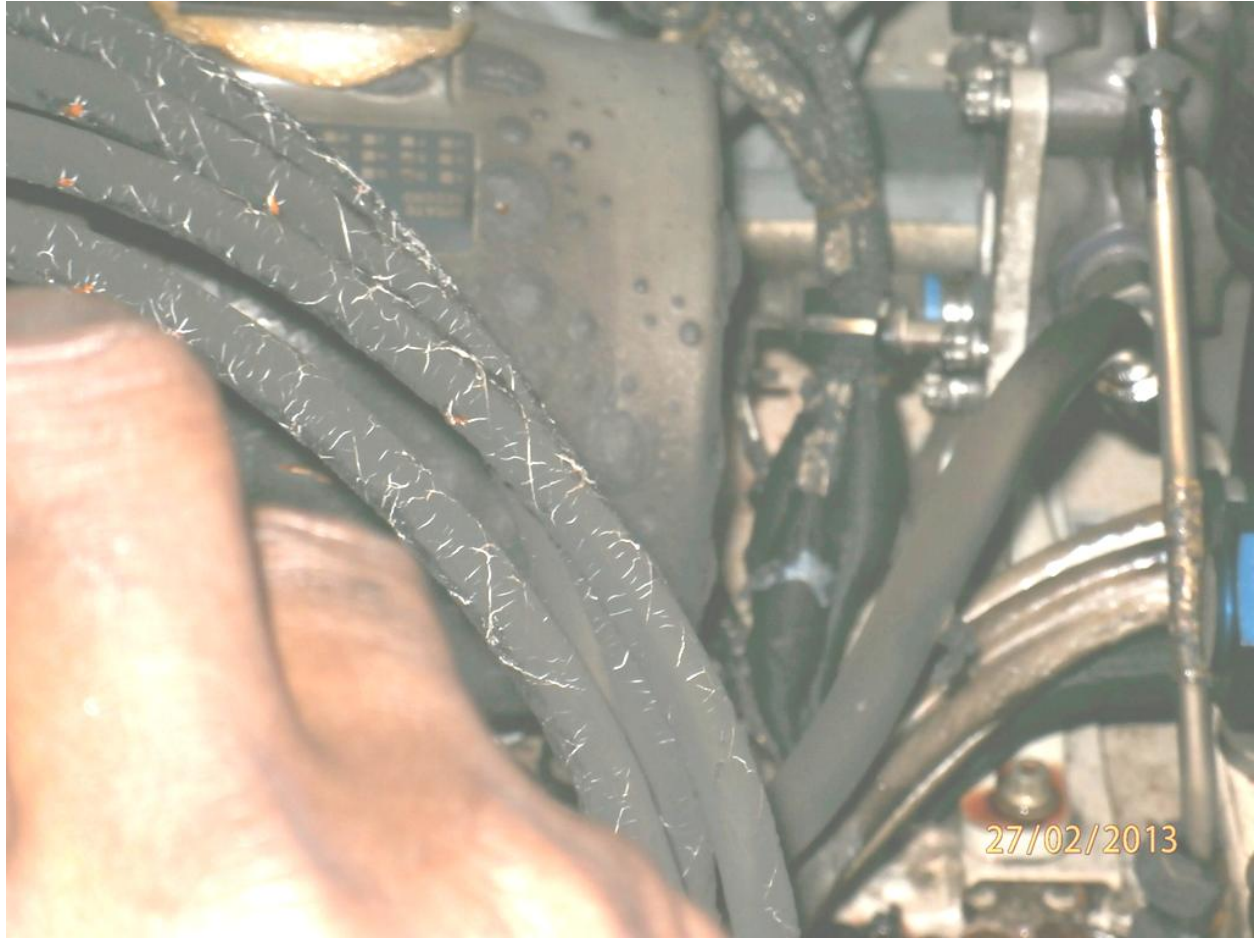
Figure 14: Burnt hoses

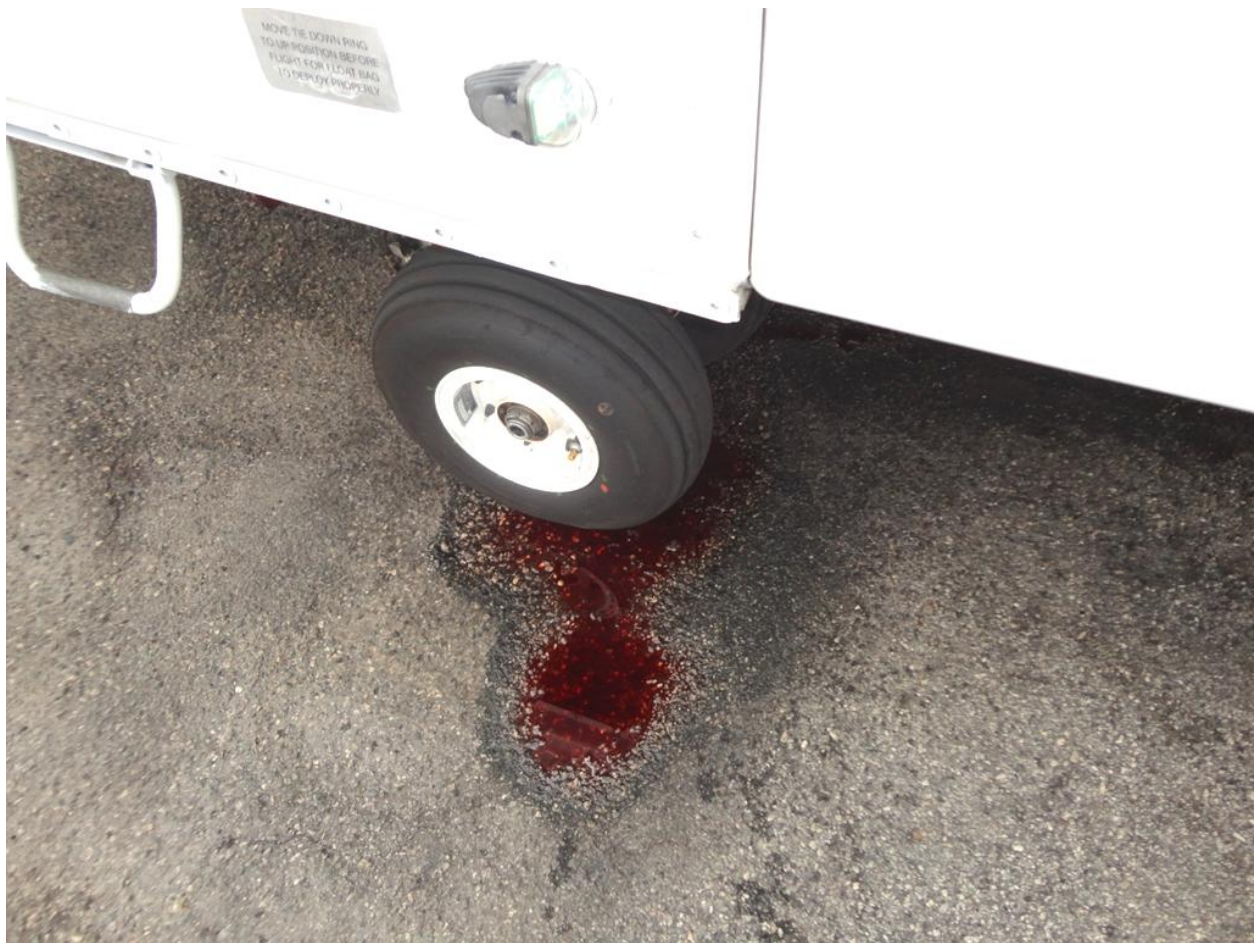
- 3.1.13 The right heat exchanger blades were damaged
- 3.1.14 The fragments of the damaged heat exchanger fan blades were not found.
- 3.1.15 There was heavy hydraulic leakage due to arcing which punctured the high pressure hydraulic pipelines.

Figure 15: Leaked Hydraulic Fluid

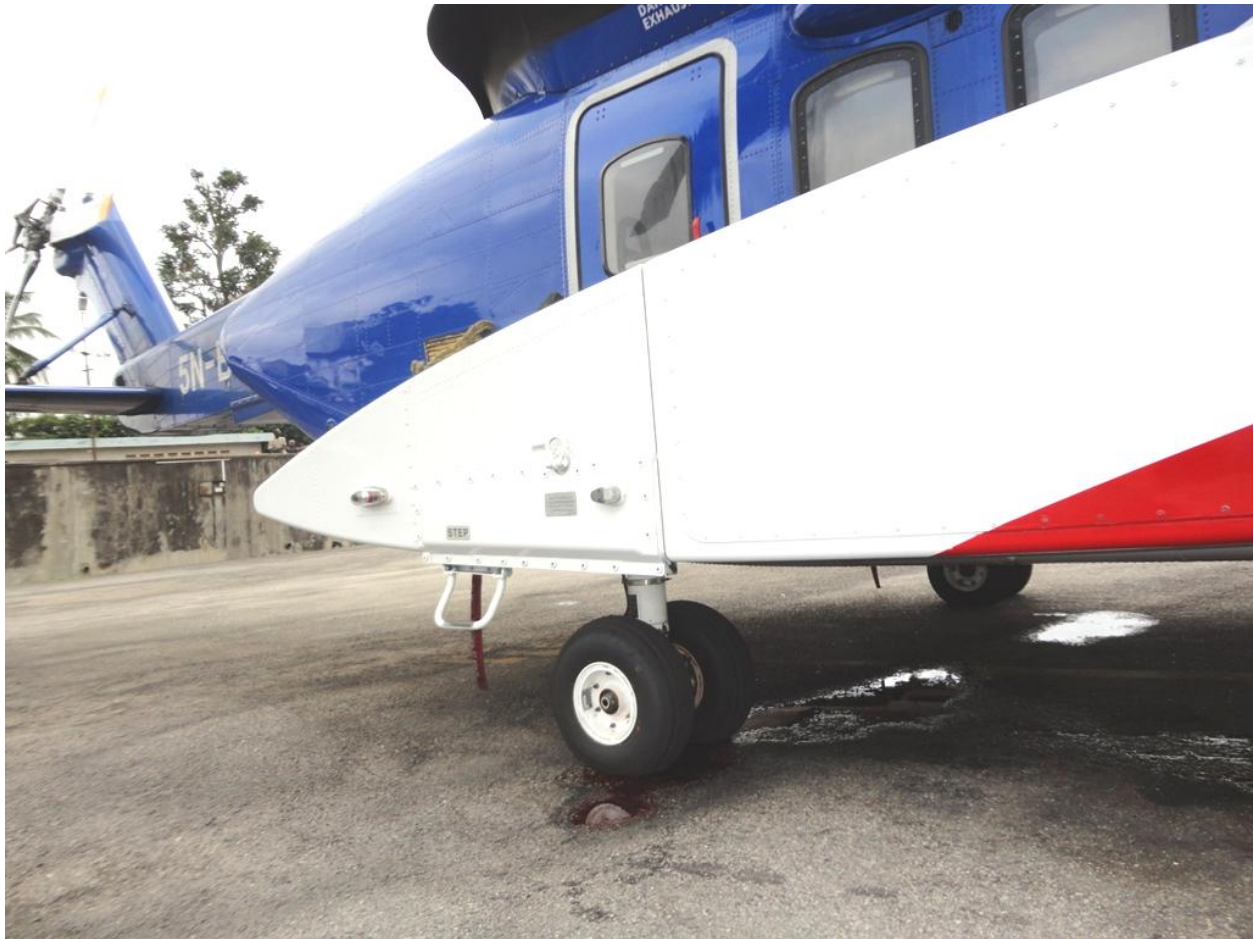
Figure 16: Leaked Hydraulic Fluid

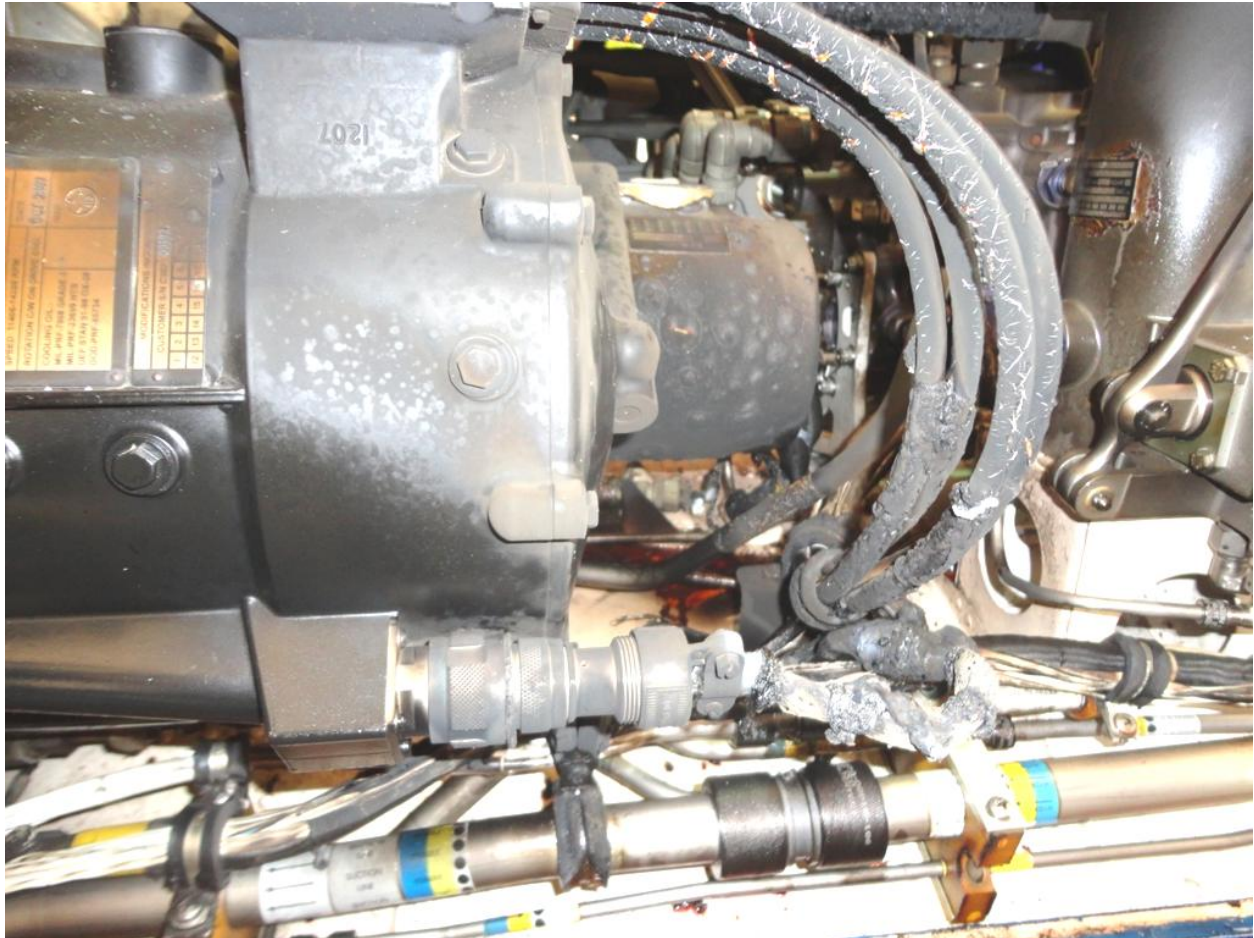
Figure 17: Burnt Out Area around the Heat Exchanger

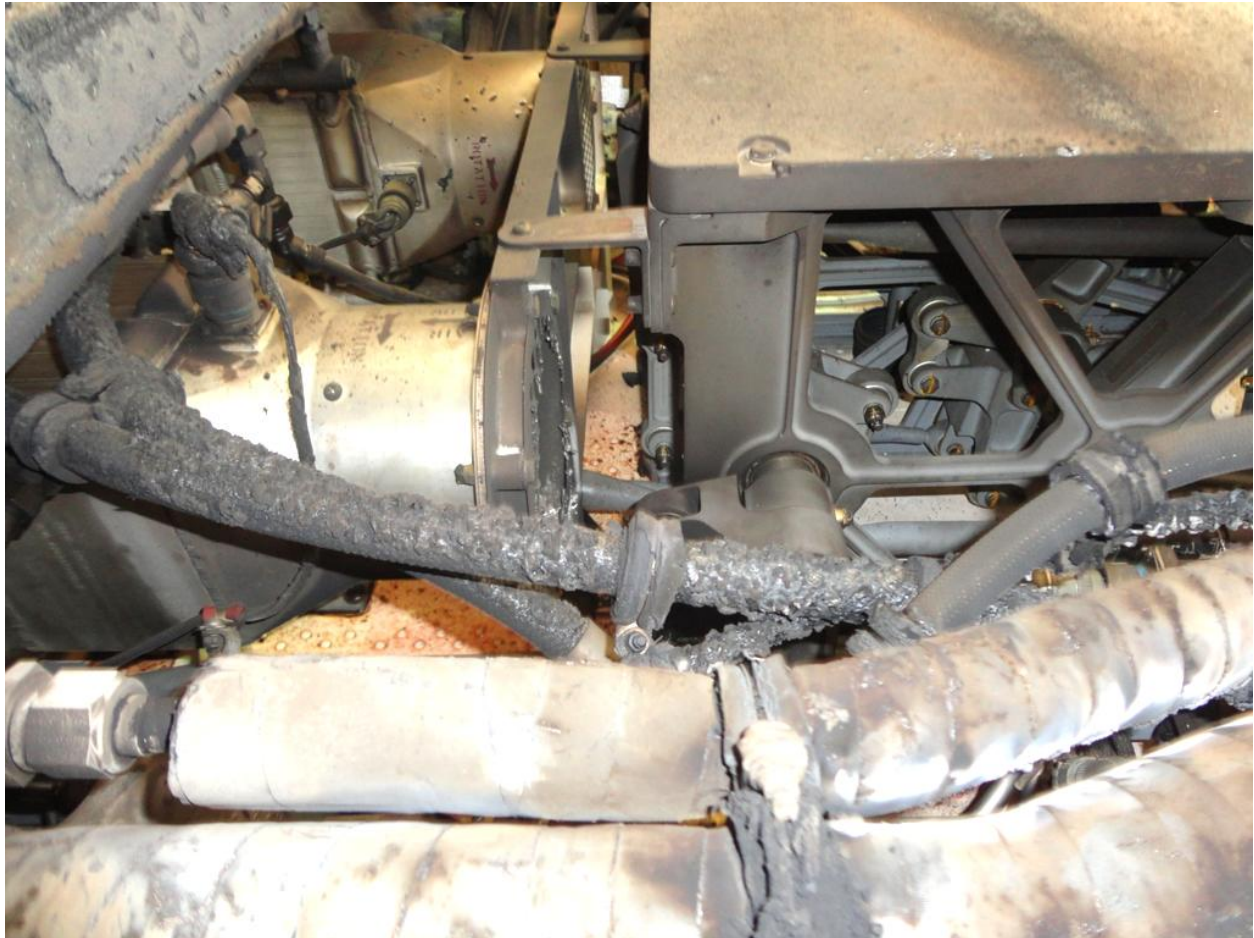
Figure 18: Burnt Out Area

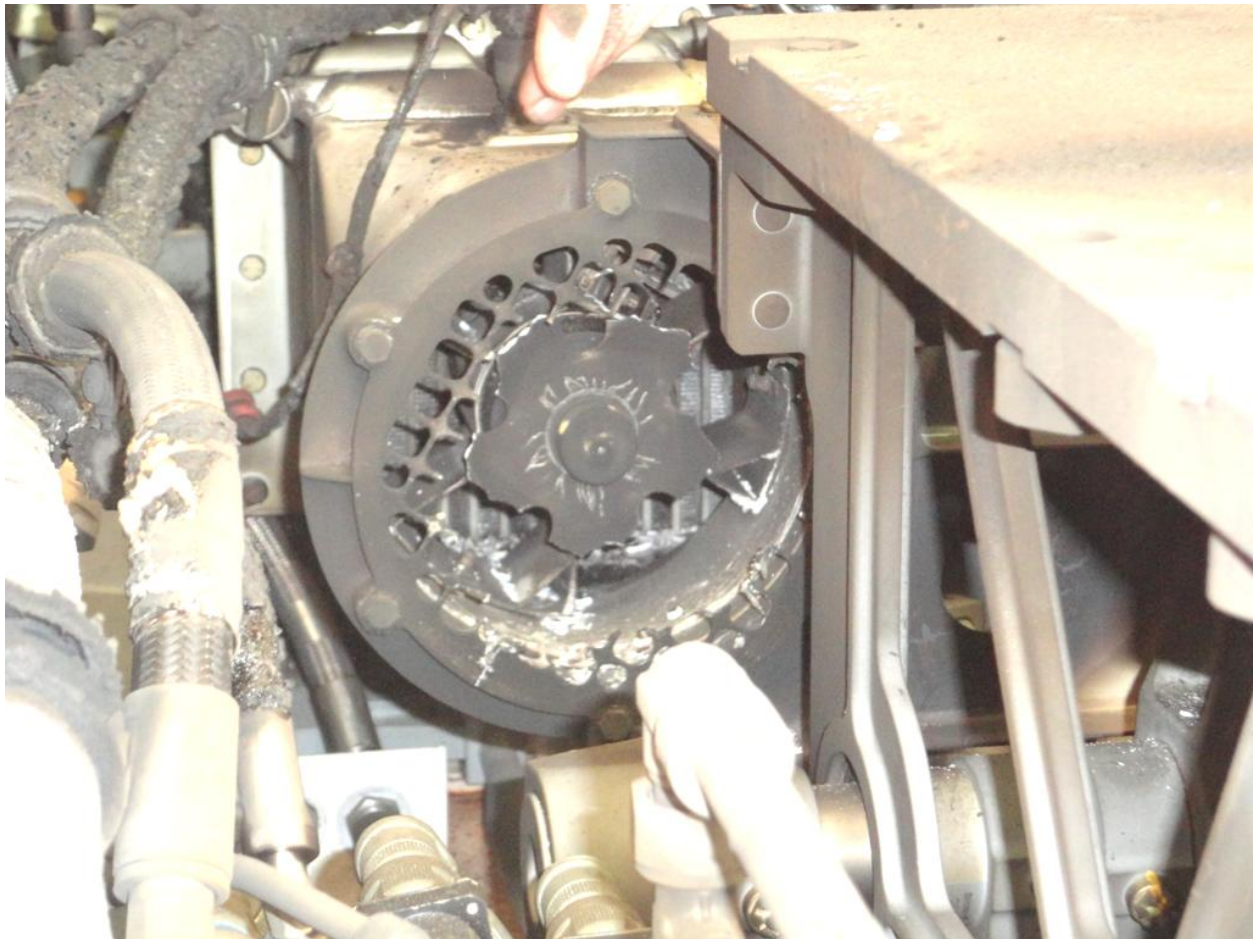
Figure 19: Damaged Right Heat Exchanger
