PRELIMINARY REPORT JULY 2024

ACCIDENT IN THE SEA VEST OF SOTRA, VESTLAND COUNTY, NORWAY 28 FEBRUARY 2024 WITH SIKORSKY S-92A, LN-OIJ, OPERATED BY BRISTOW NORWAY AS

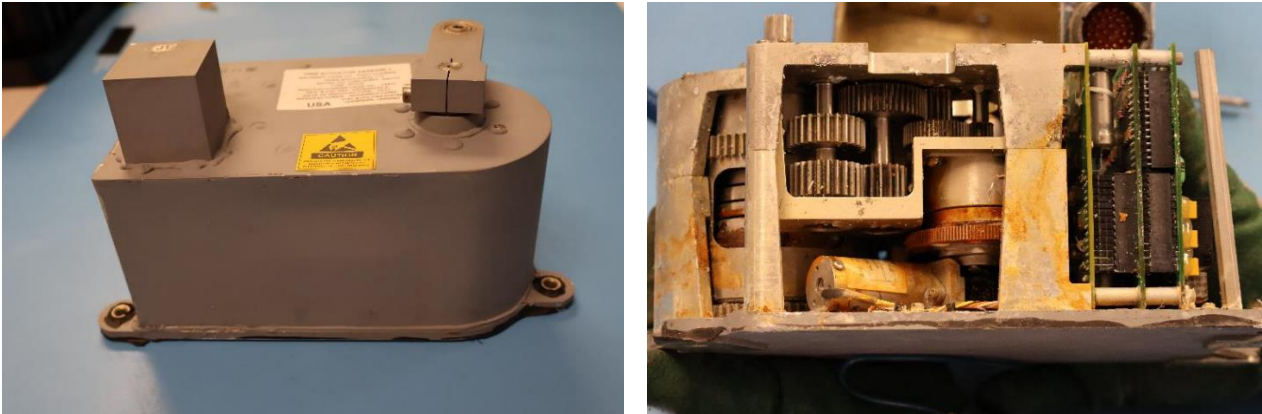
After thorough investigation in cooperation with the manufacturer of the trim servo system and together with both NTSB and Sikorsky a fault was found on one of the three circuit boards in the pitch trim servo, see fig. 2 and 3. This fault appears to have a potential of explaining the helicopter movement seen in the recorded data. A total of 12 circuit boards were tested, three from each of the four trim servos. Two circuit boards had physical damage and failed during tests. No other faults were found on the remaining 9 circuit boards. The fault in the pitch trim servo is still under investigation.

Figure 2: The pitch trim servo as found and opened showing circuit boards. Photo: Collins Aerospace/NSIA
