Accident Reference: ACCID/071620/01-02

**Aircraft Accident Investigation Preliminary
Report**

Helicopter Collision with Terrain
Private Flight
Mc. Donnell Douglas, 1997 MD 600N Helicopter,
V5-HVD near Heja lodge, Windhoek
16th July, 2020

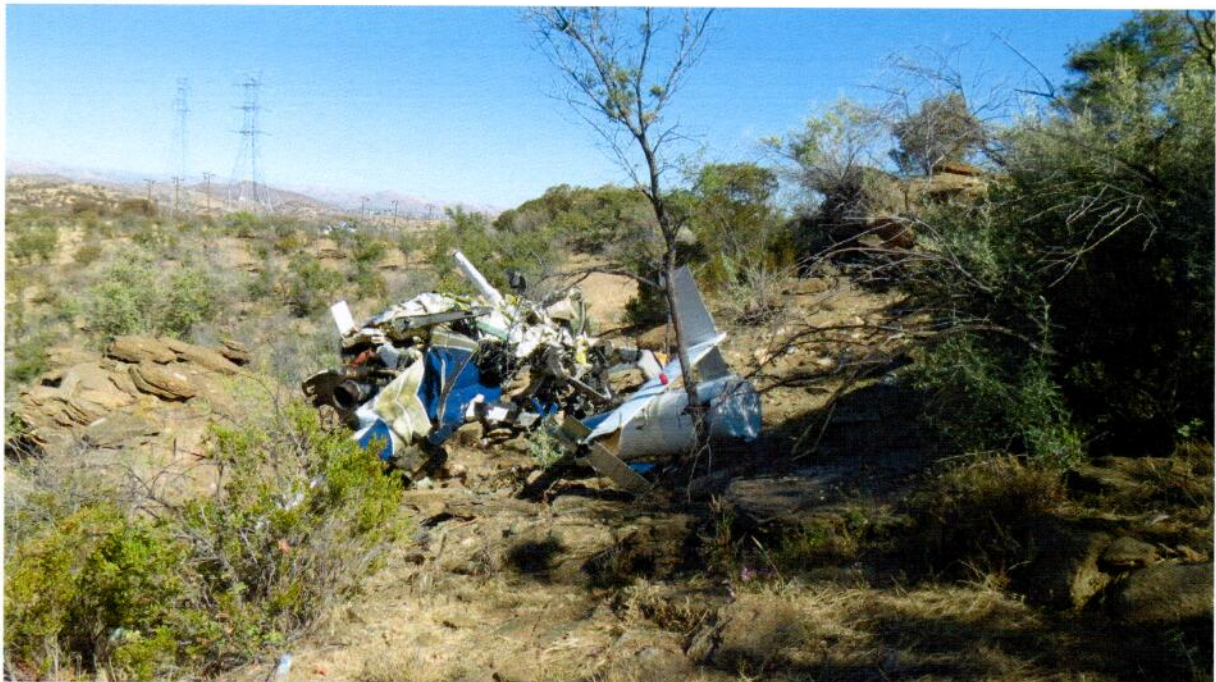
The helicopter struck the ground at a shallow angle and the right skid broke off. The door, pedals and other minor components were found on top of the ridge which was the helicopter's first point of impact. The rest of the wreckage tumbled down approximately 40 meters down the ridge.
The cockpit/cabin livable area was severely disrupted.

Figure 1. Photo depicting the final resting position with visible high voltage power lines ahead.

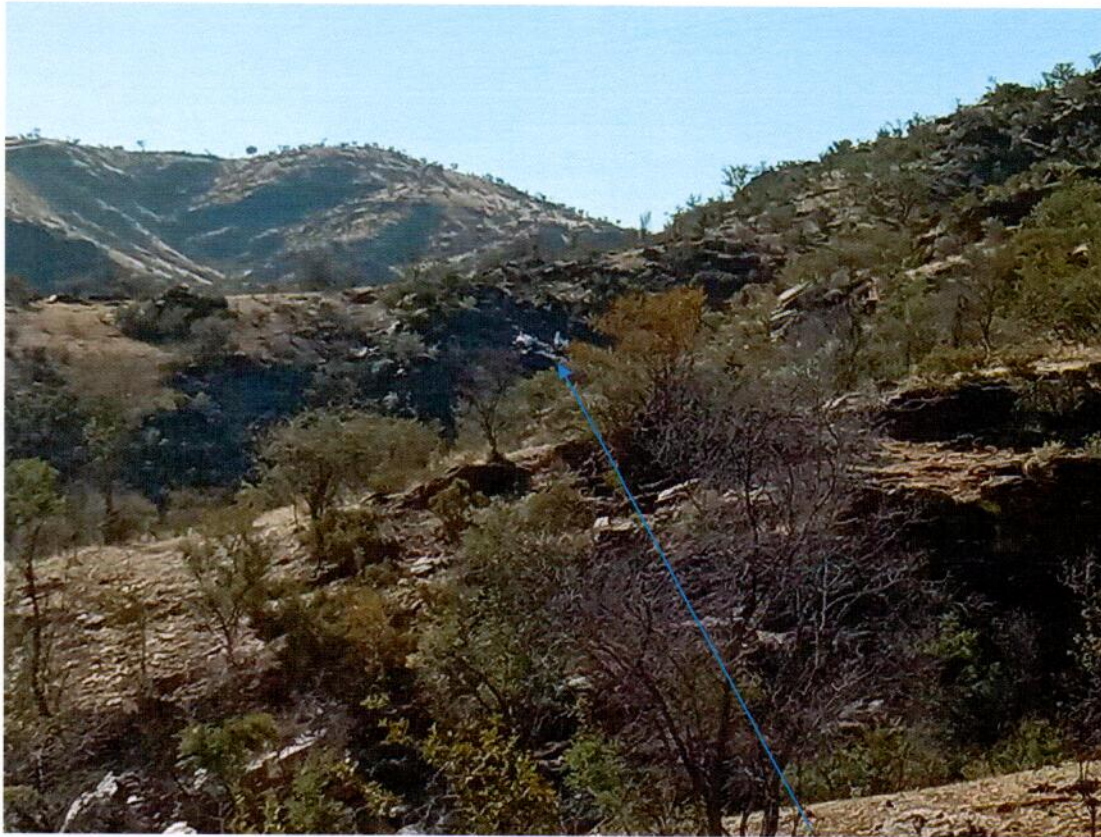
Figure 2. Depicting aircraft wreckage position half way down the steep ridge.

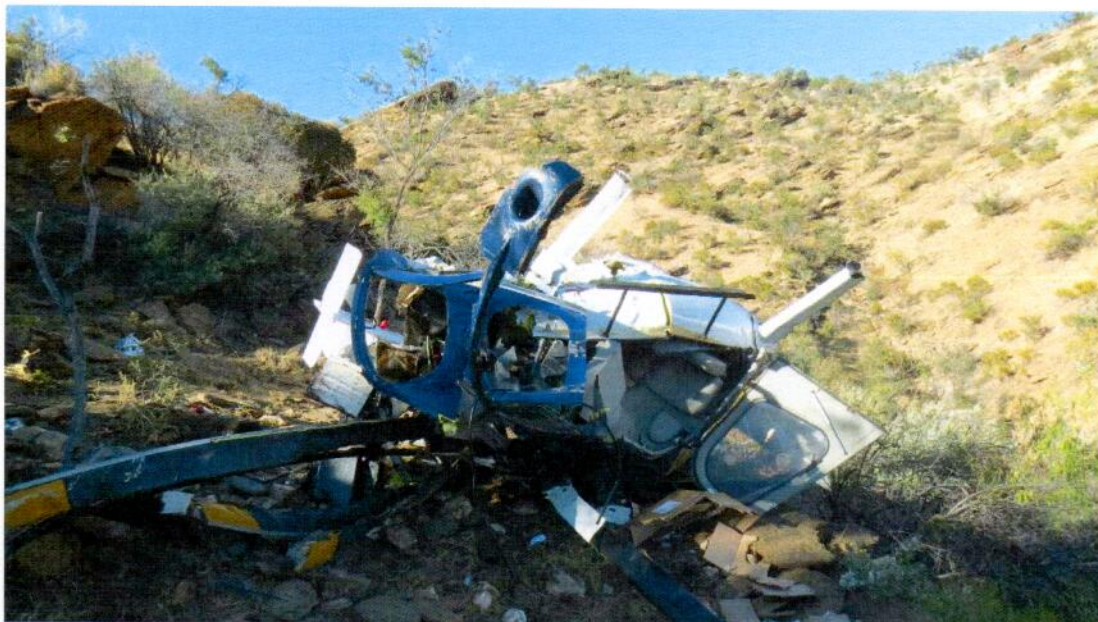
Figure 3. Depicting aircraft inverted position with cabin livable space reduced.
