To: Accident Case File #: MD600N/RN045
N613BP, US Border Patrol Air Operations
San Diego, California
NTSB Identification: WPR10TA016

From: John Hobby, Chief Accident Investigator, MD Helicopters Inc.

Subject: Field Investigation Notes
October 19, 2009 at CBP Hanger, Brown Field, San Diego CA

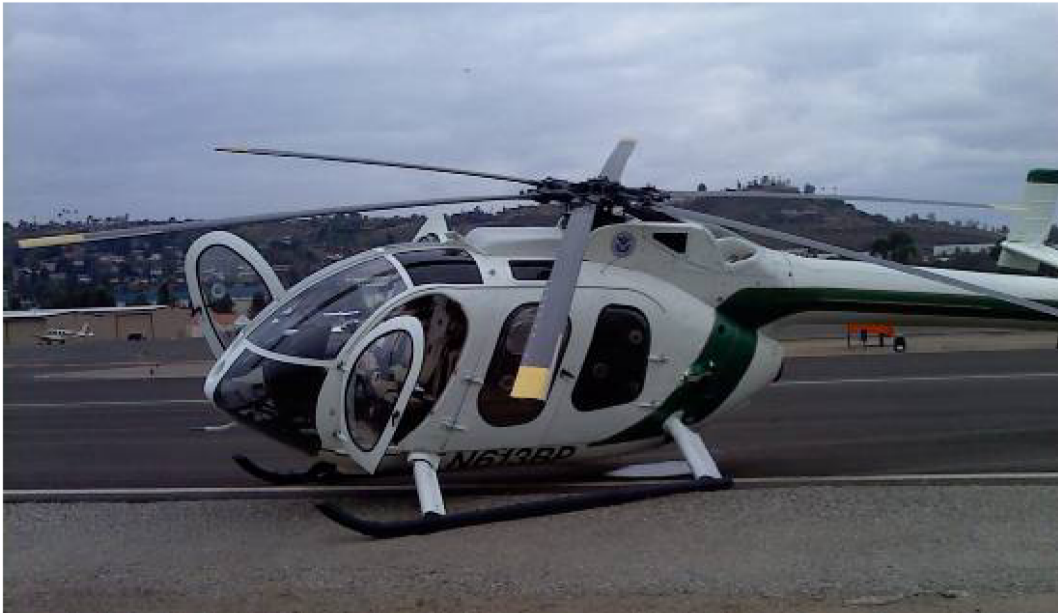
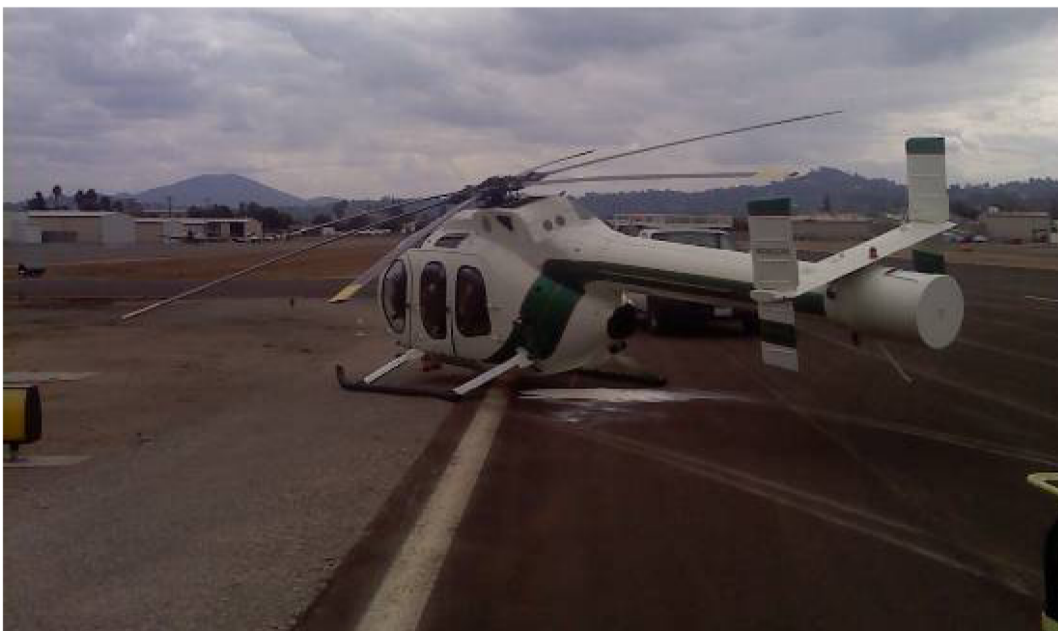
Incident Site

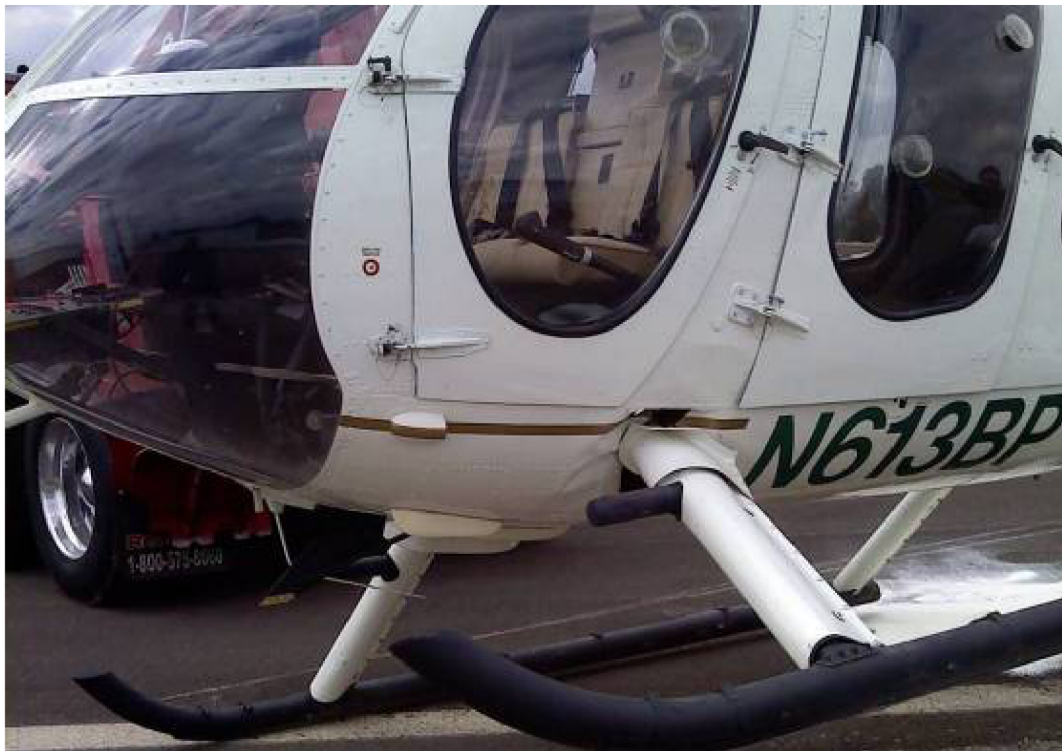
The helicopter exhibited extensive damage to the left side of the airframe in the area of the outboard landing gear damper attachment structure. The left landing gear struts were not broken but completely spread with the landing gear damper attachment structure torn and the structure severely deformed from the landing gear strut/damper over travel. The left landing gear struts were gouged and scratched in the area where they pass through the fuselage. The aft left landing gear damper upper cap was bent and the forward left lower damper cap was separated from the damper body from the over travel. The landing gear strut and brace attachment fittings on the center beam appeared undamaged. However, there were contact marks on the fittings indicating over travel. There was no visual damage to the right struts or fuselage strut attachment structure. The canopy, upper fuselage and belly of the aircraft were undamaged.

Left Forward Landing Gear

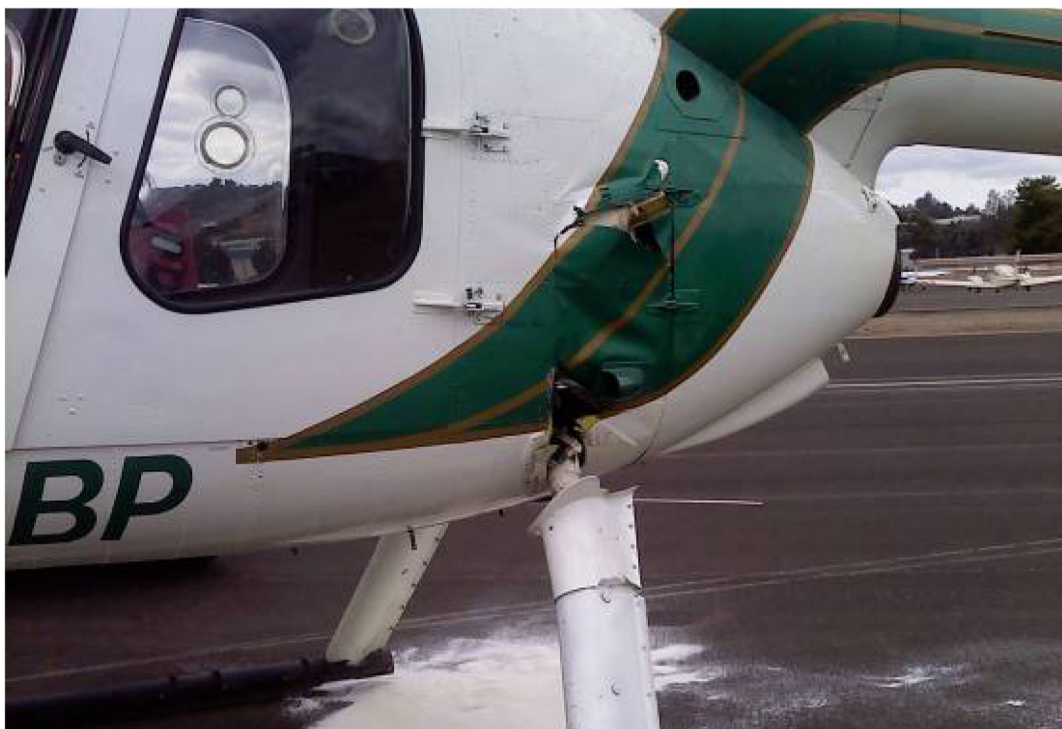
Left Aft Landing Gear

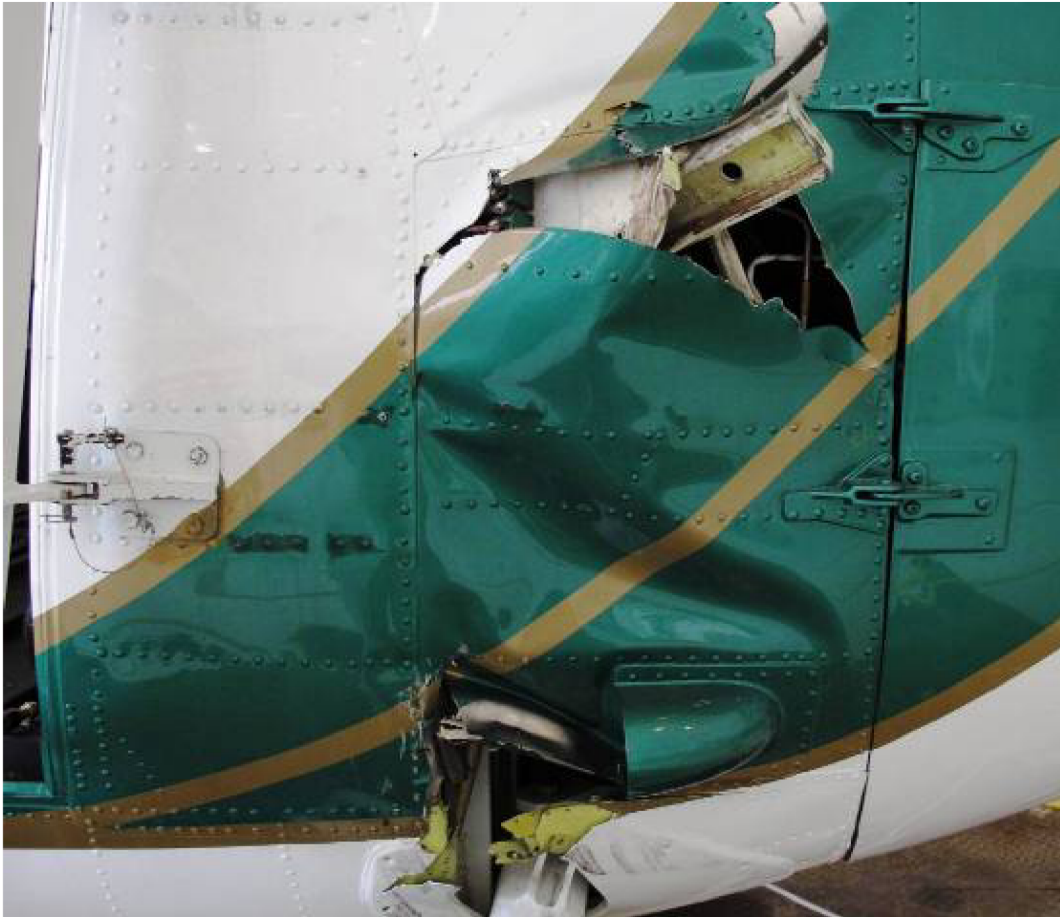
Aft Left Landing Gear Attach Structure

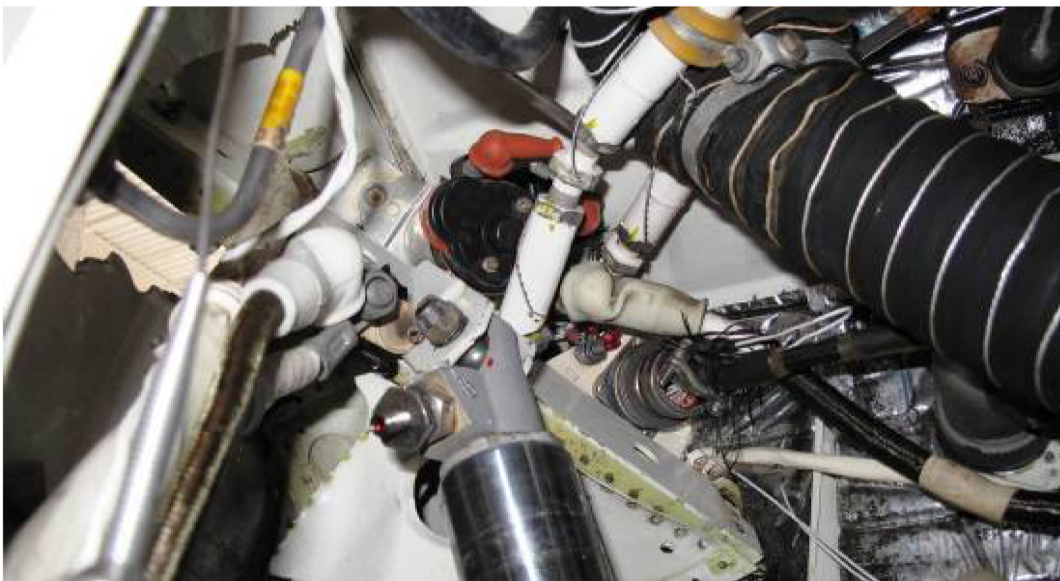
The aircraft was equipped with a Rolls-Royce 250-C47M Turbo shaft engine, SN: CAE-847825. The left engine mount was bent and fractured due to the engine mount attachment to the landing gear damper fitting that was displaced by impact damage. No engine related issues are suspect or reported by the pilots.

Aft Left Landing Gear Damper Attach and Engine Mount

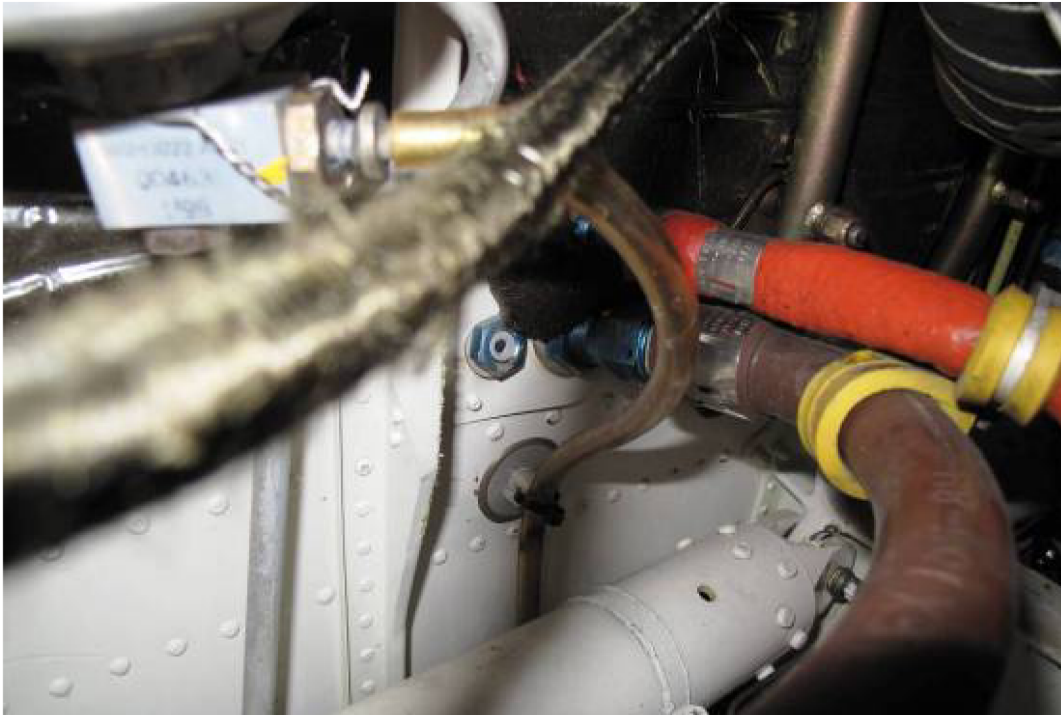
The main fuel tank contained approximately 600 pounds of fuel. The engine fuel pump return line fitting was broken at the engine firewall and a small amount of fuel from this line leaked on the runway. The broken fitting appeared to be related to the landing gear strut/damper and engine mount attachment fitting damage. No other fuel leaks were reported.

Engine Fuel Pump Return Line Fitting

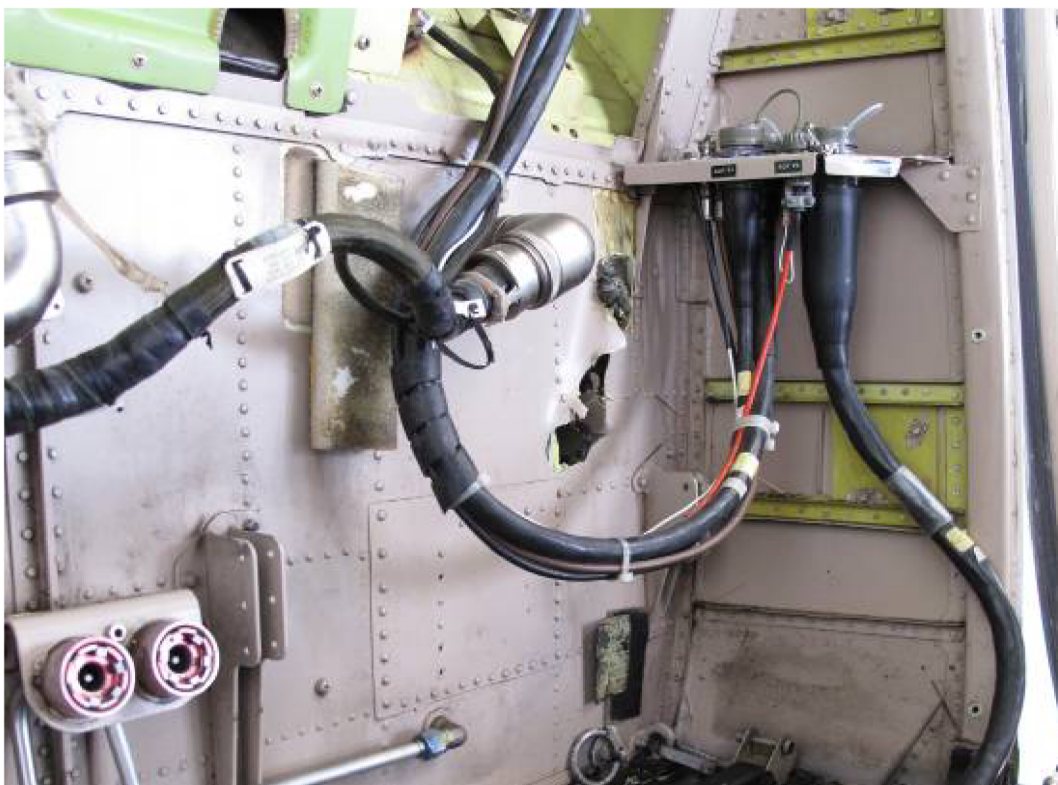
Left Cabin Area, Station 124.0

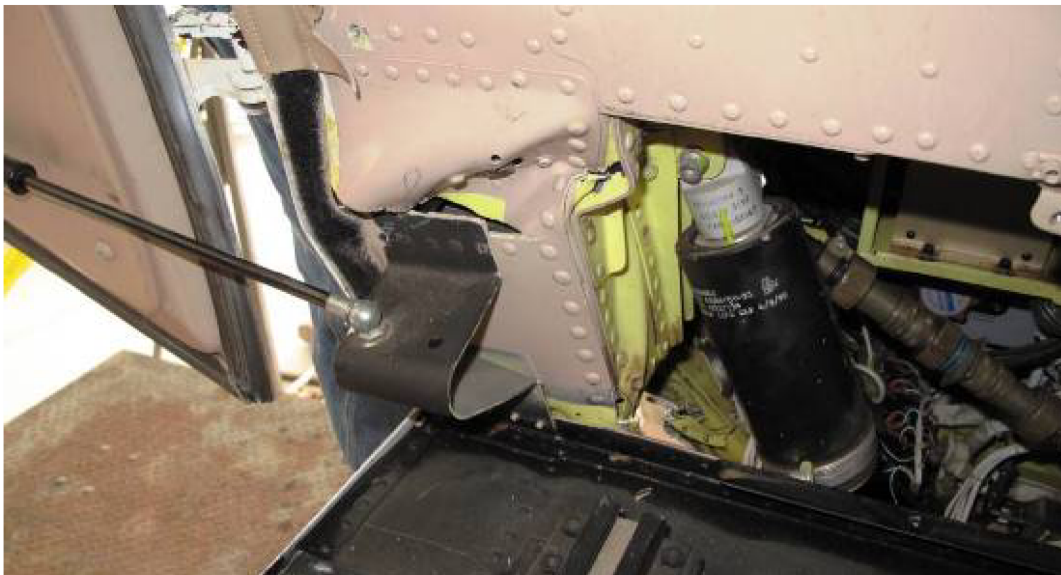
The instrument and center console slant panel showed no evidence of damage. Both cockpit seat box structures were modified to incorporate a removable style access cover. There was some waviness to the left seat structures aft section but it is suspect that this was due to the landing gear forward strut/damper attachment damage. There was no noted damage to the right seat box structure. The crew and passenger restraint system functioned normally and the attachment points showed no evidence of damage.

Left Cabin Cant. Station 78.50 and Foot Well Area

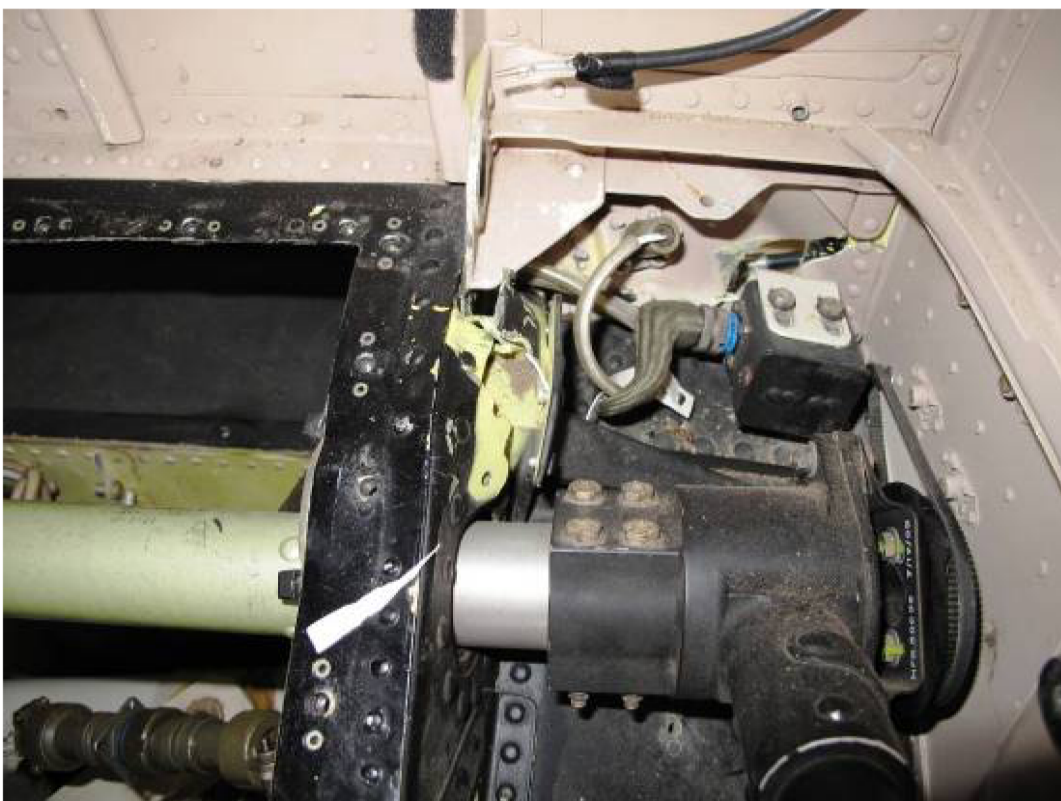
Left Collective and Damper Attach Fitting
